# Key Largo Wastewater Treatment District Board of Commissioners Meeting Agenda Item Summary

Subject:  
**Field Report - February 2025**

## Wastewater Field Operations

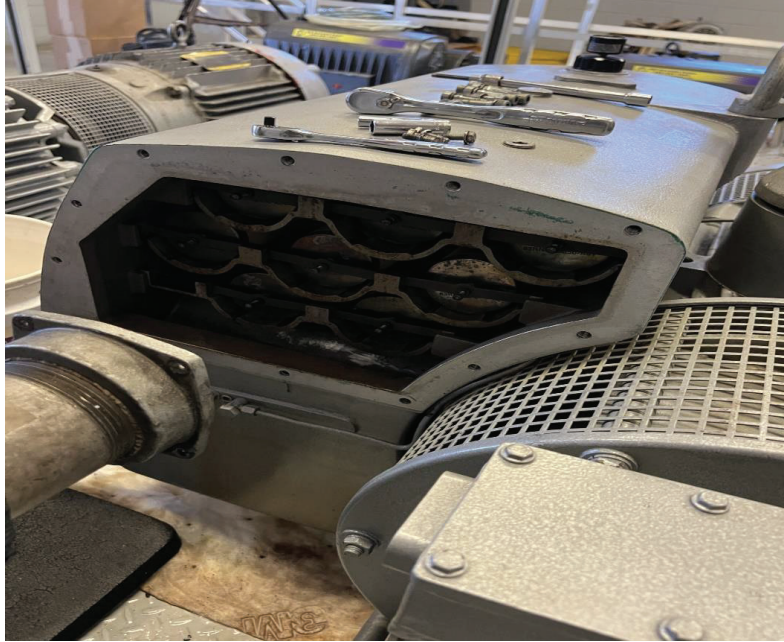
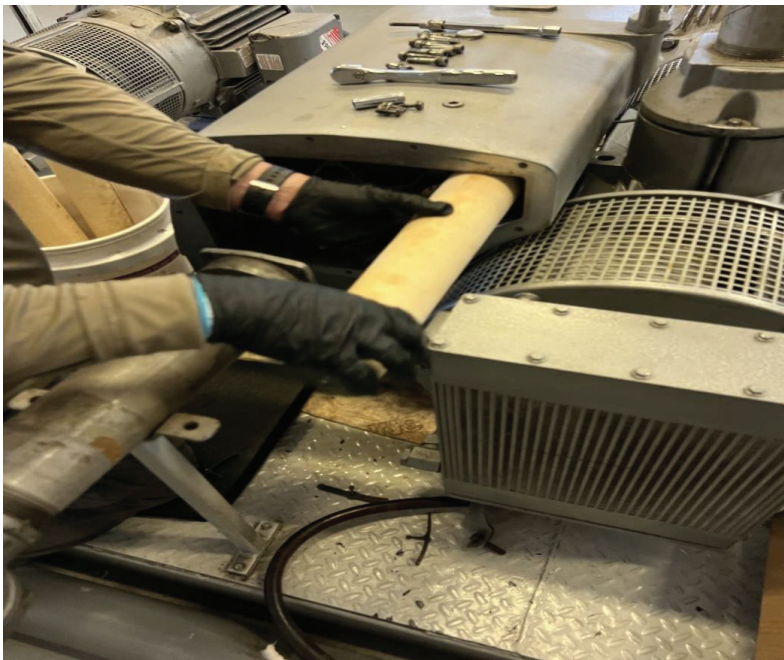
Removal of the old exhaust filters. (Exhaust filters are part of our maintenance requirements that we do on our vacuum pumps 1 a year).

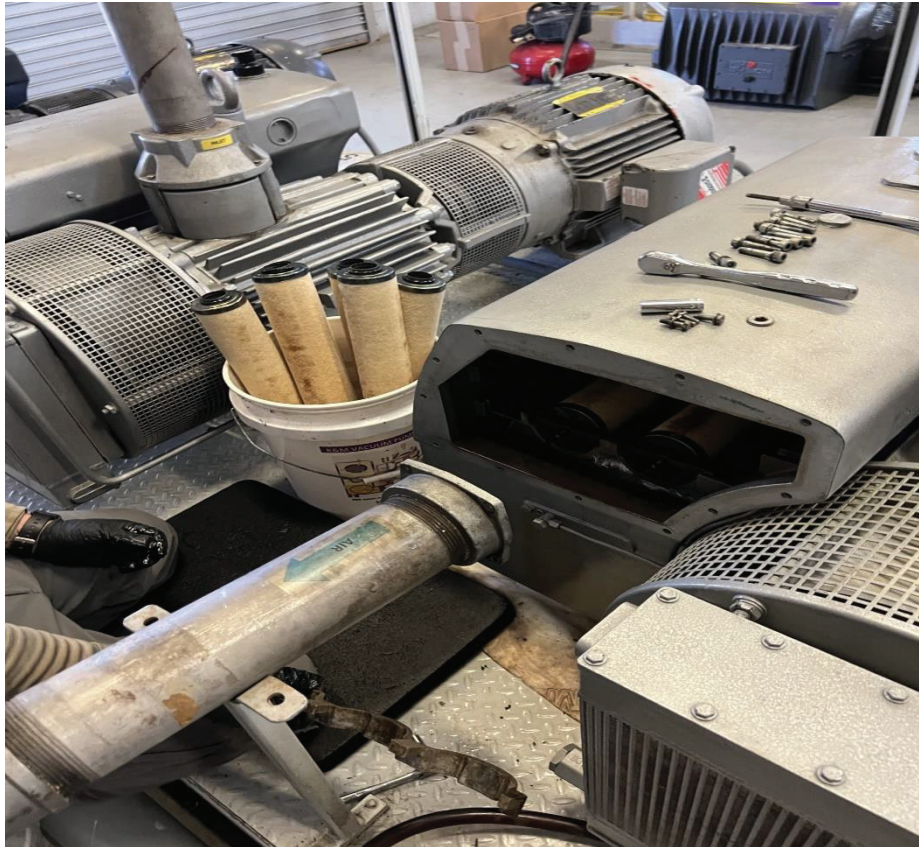
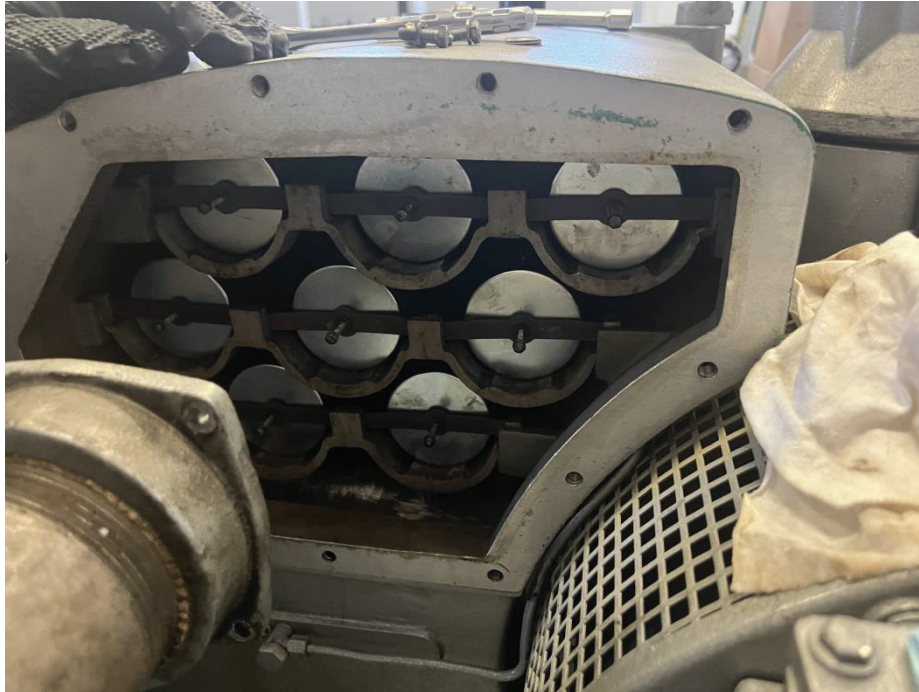
This picture shows the completion of the exhaust filters. Exhaust filters catch the oil vapors and any debris before it turns back into a liquid form and drains back into the return line.

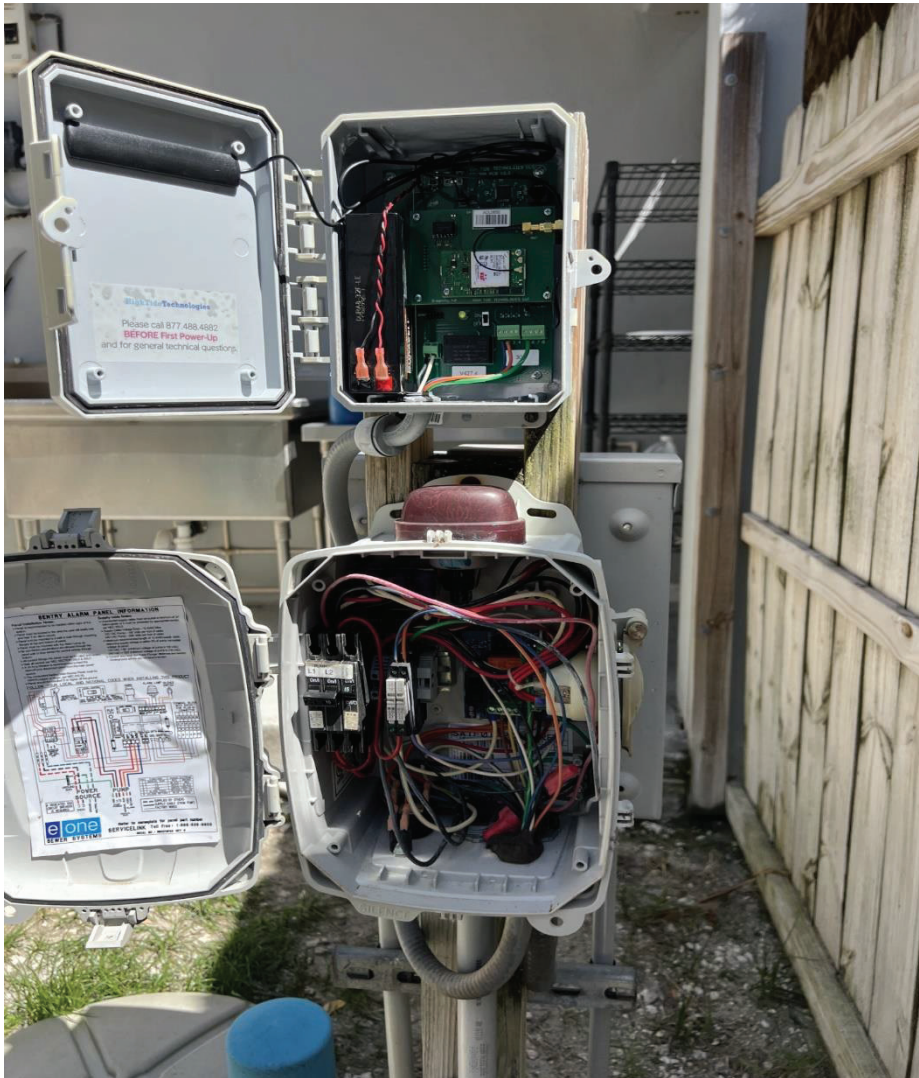
Field techs providing assistance to Flo Vac with the installation of the Low Pressure Monitoring.
