# Key Largo Wastewater Treatment District Board of Commissioners Meeting Agenda Item Summary

**Field Report - March 2025**

## Wastewater Field Operations

***3 month interval oil change process***

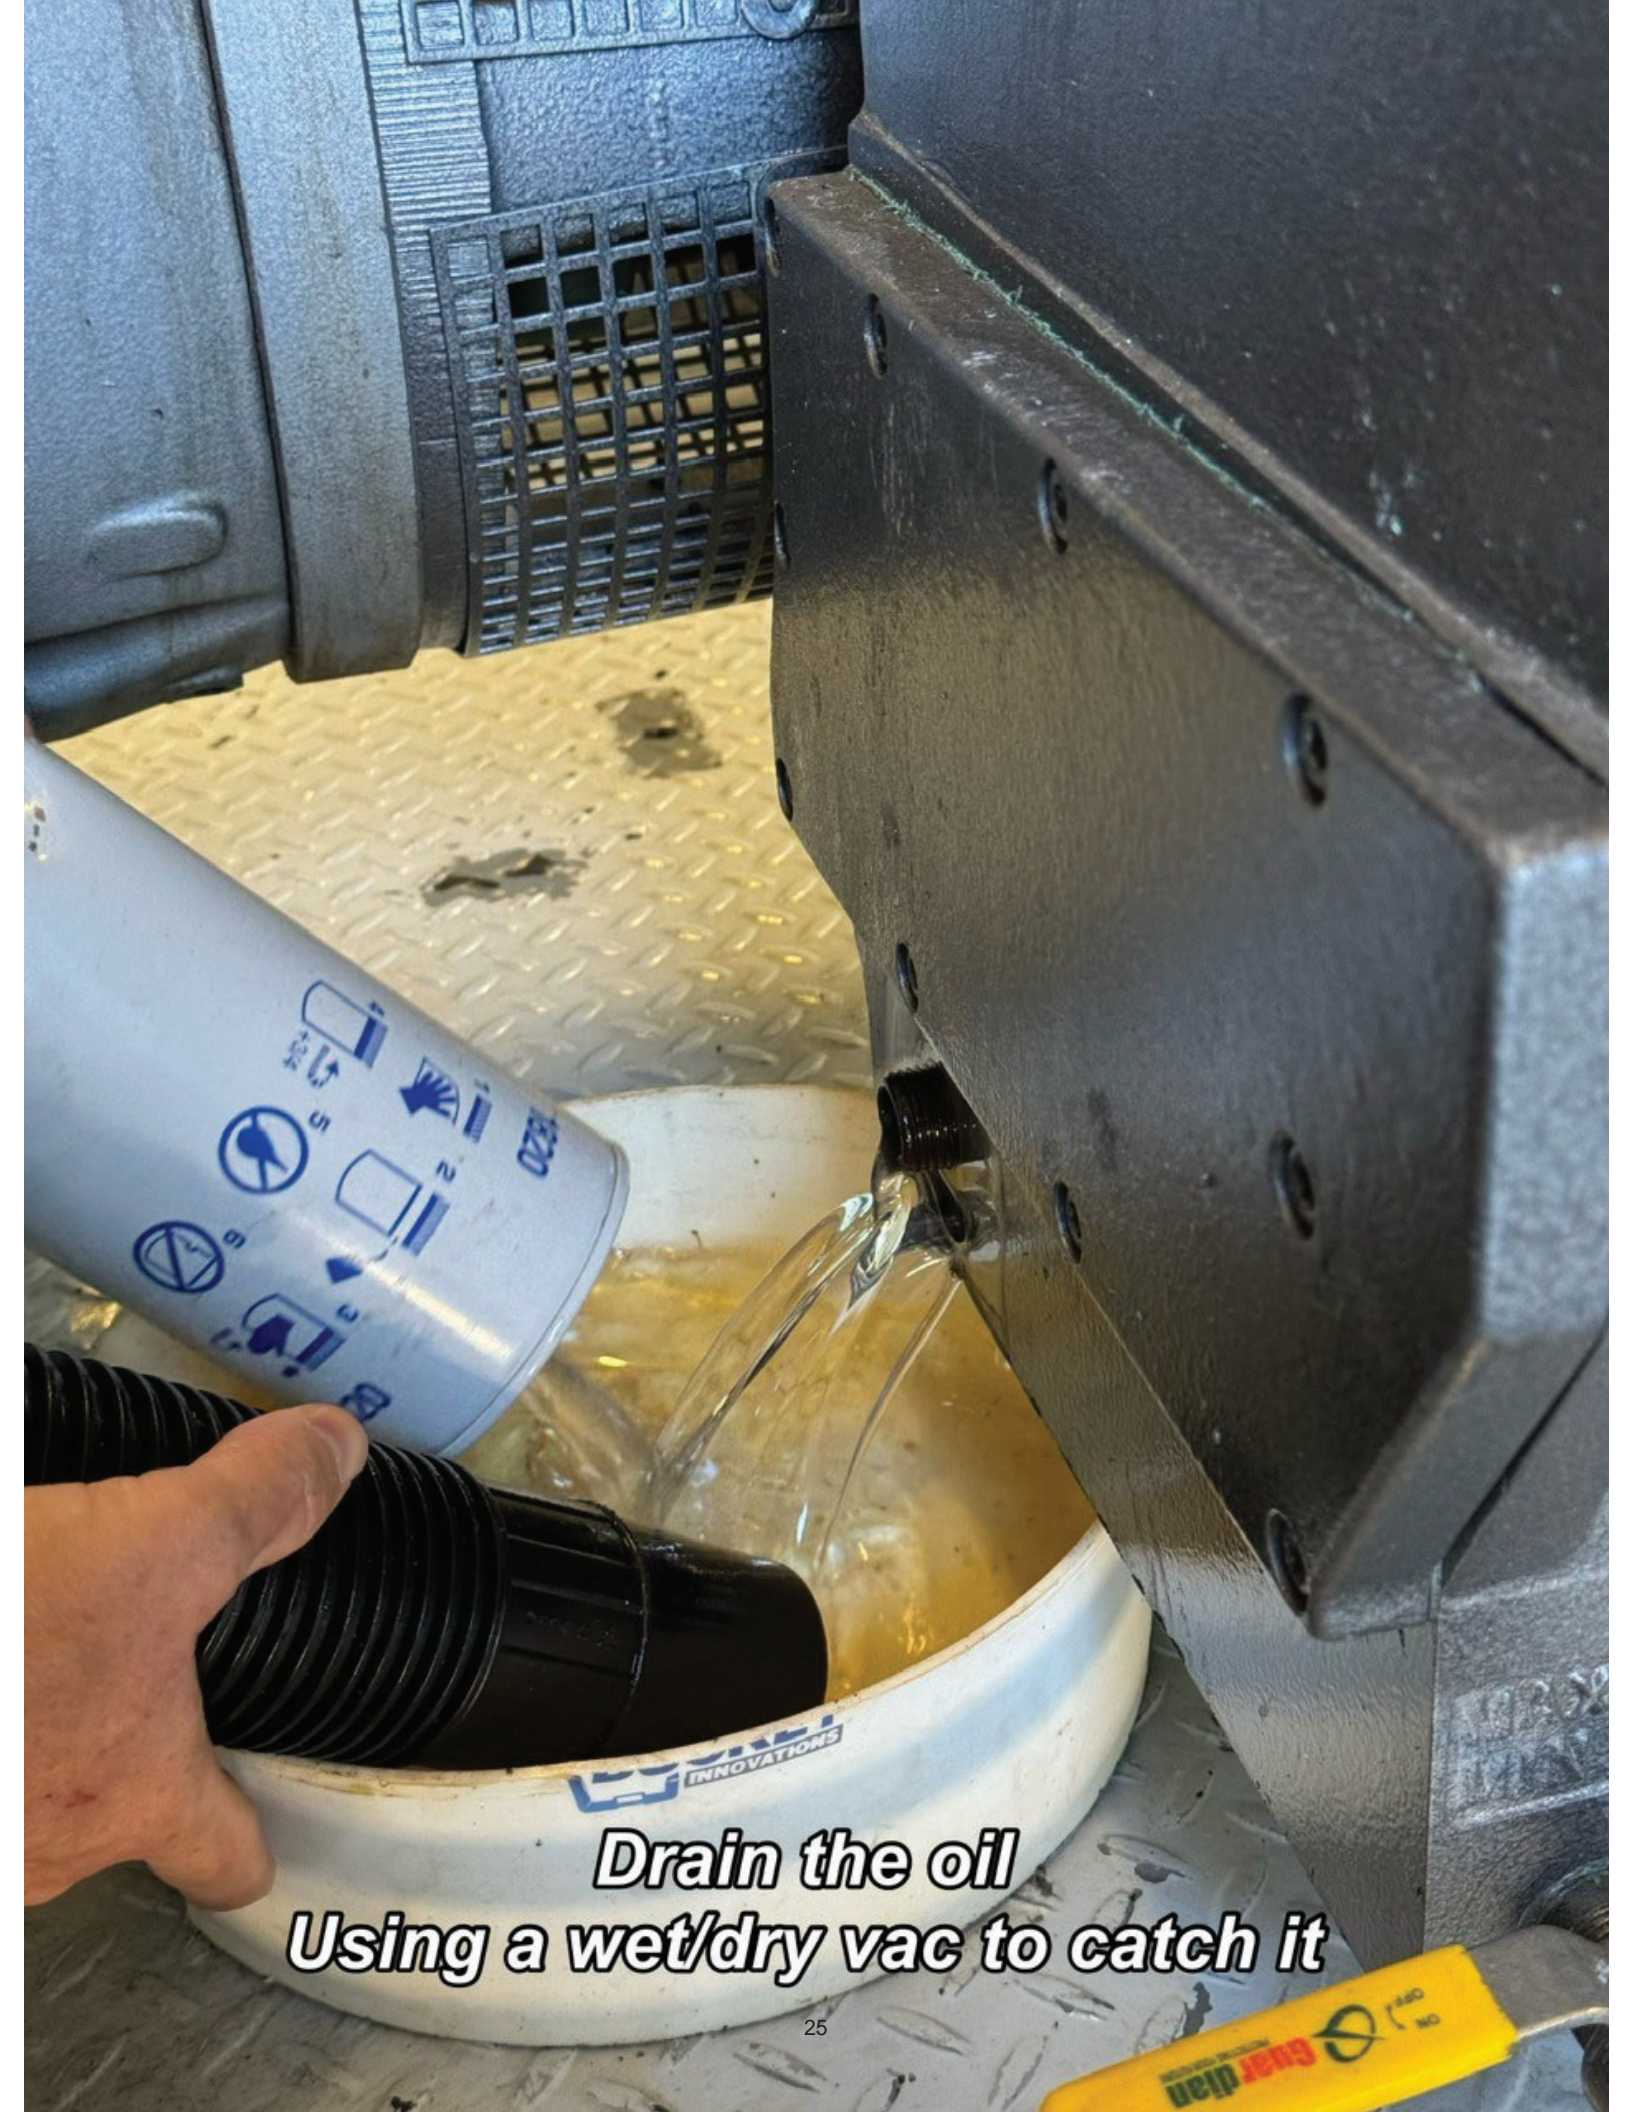
***Drain the oil  
Using a wet/dry vac to catch it***

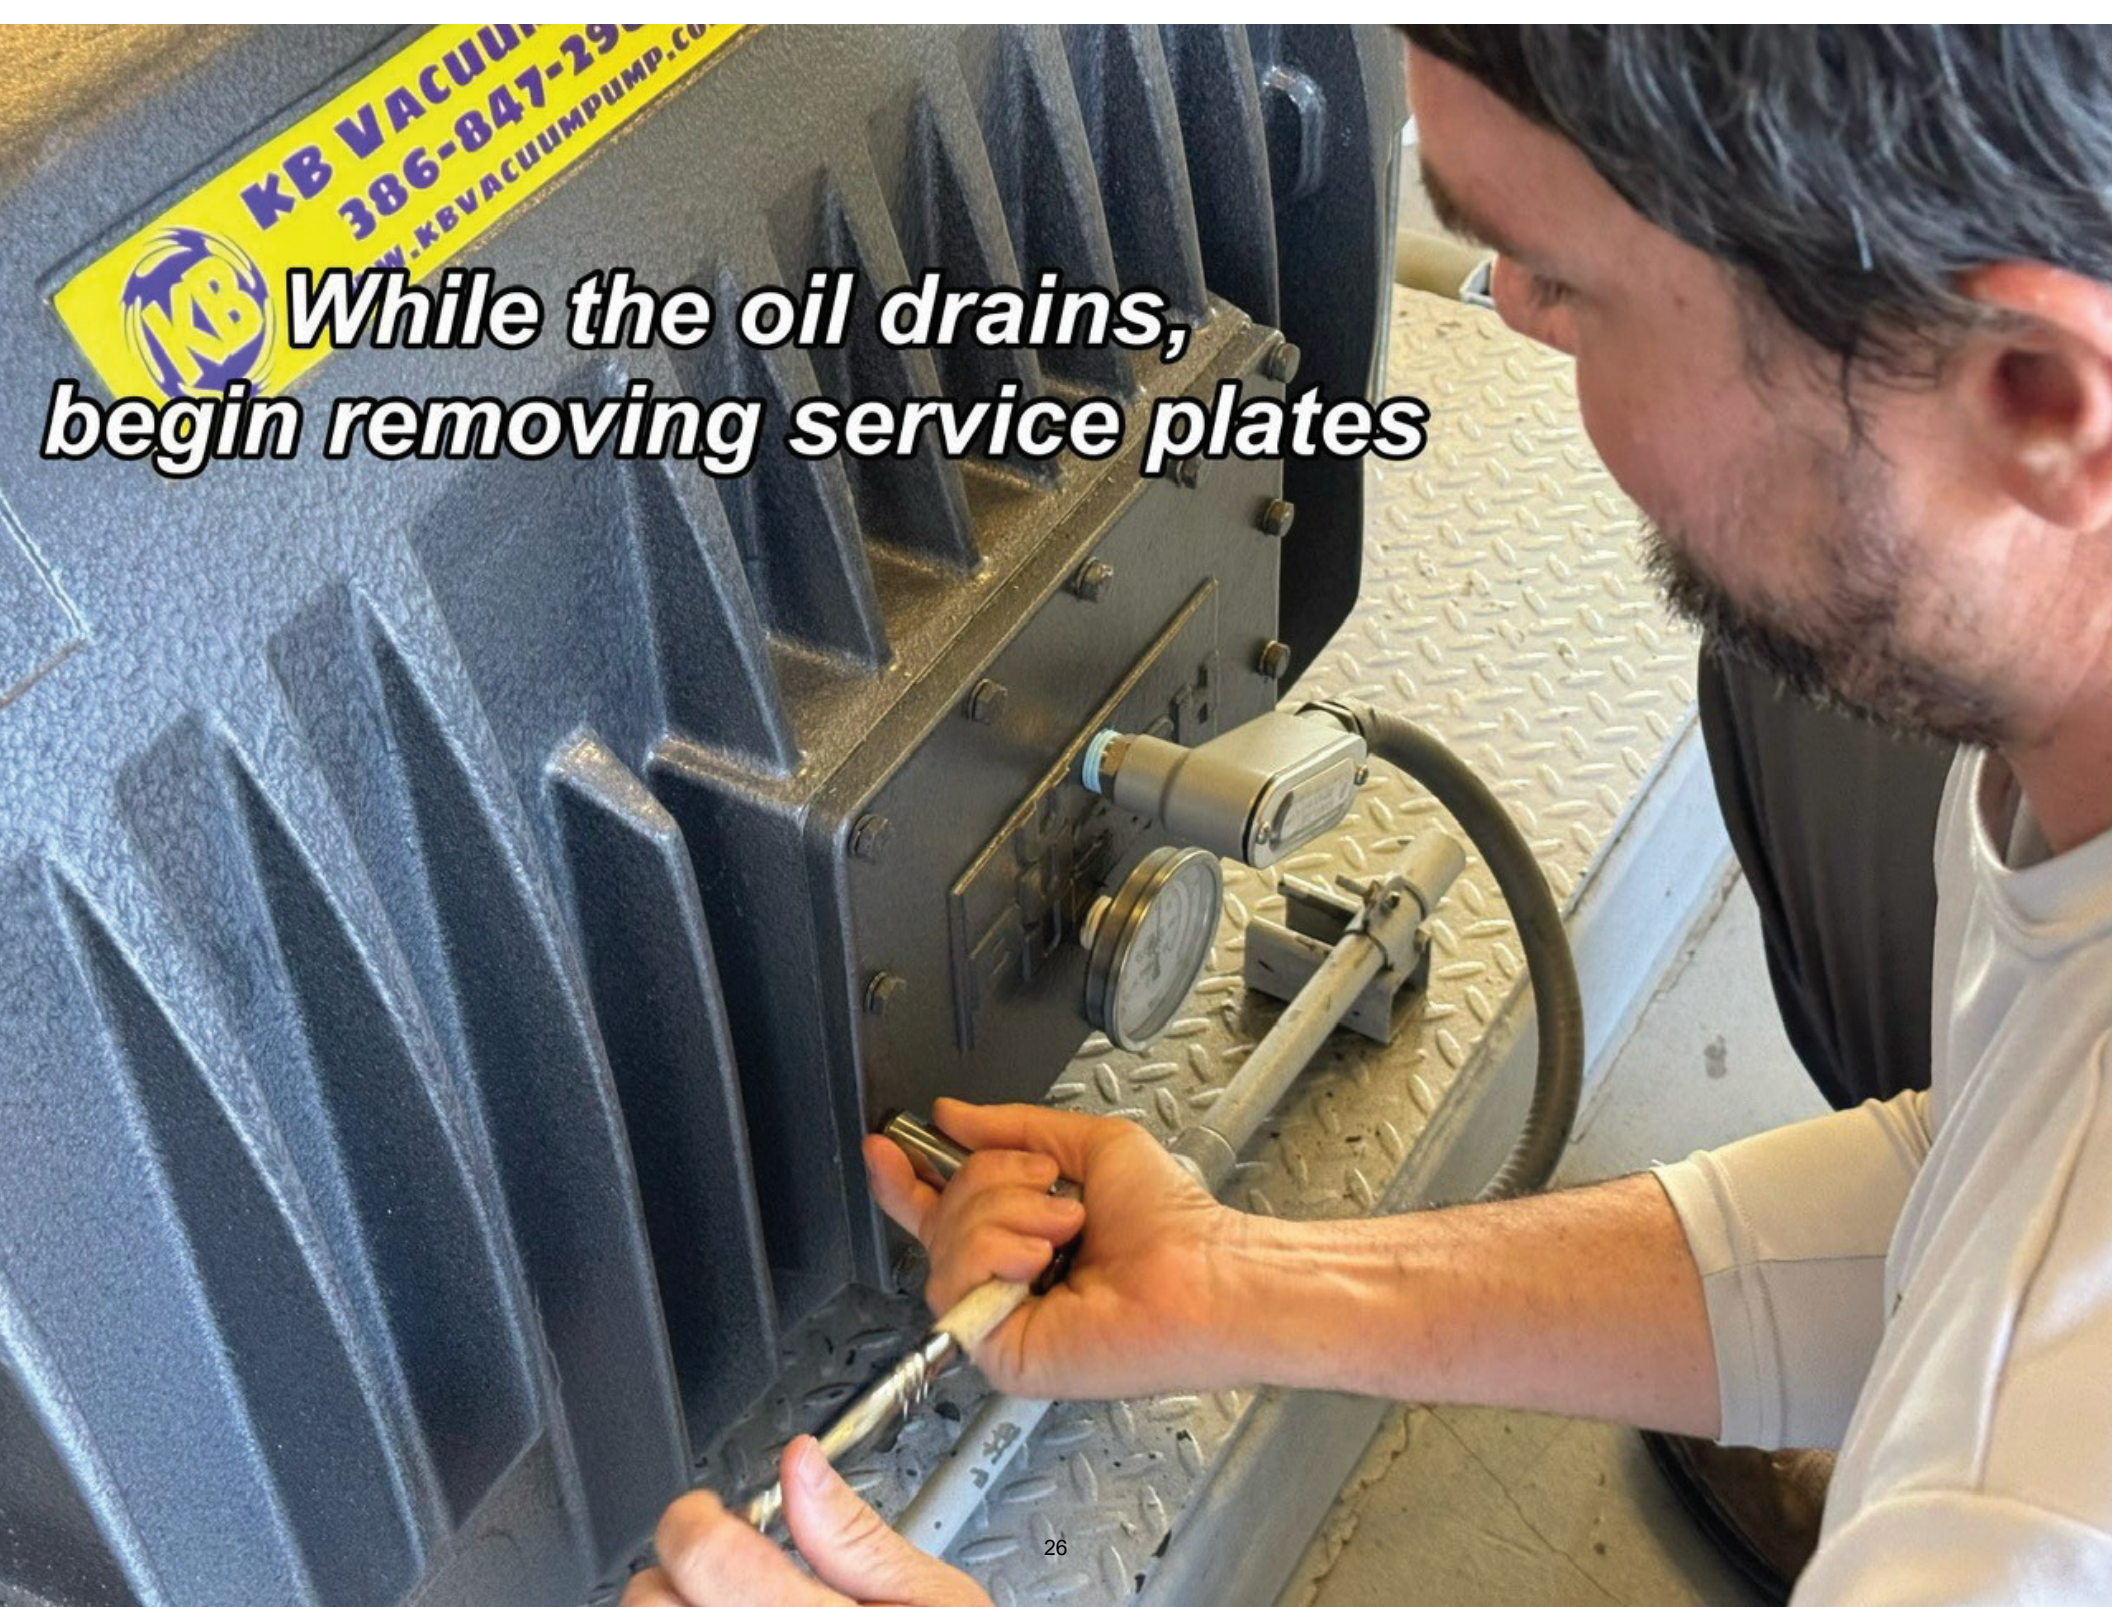
***Inspect gasket for tears,  
Inspect helicoils making sure they're flush with the surface***

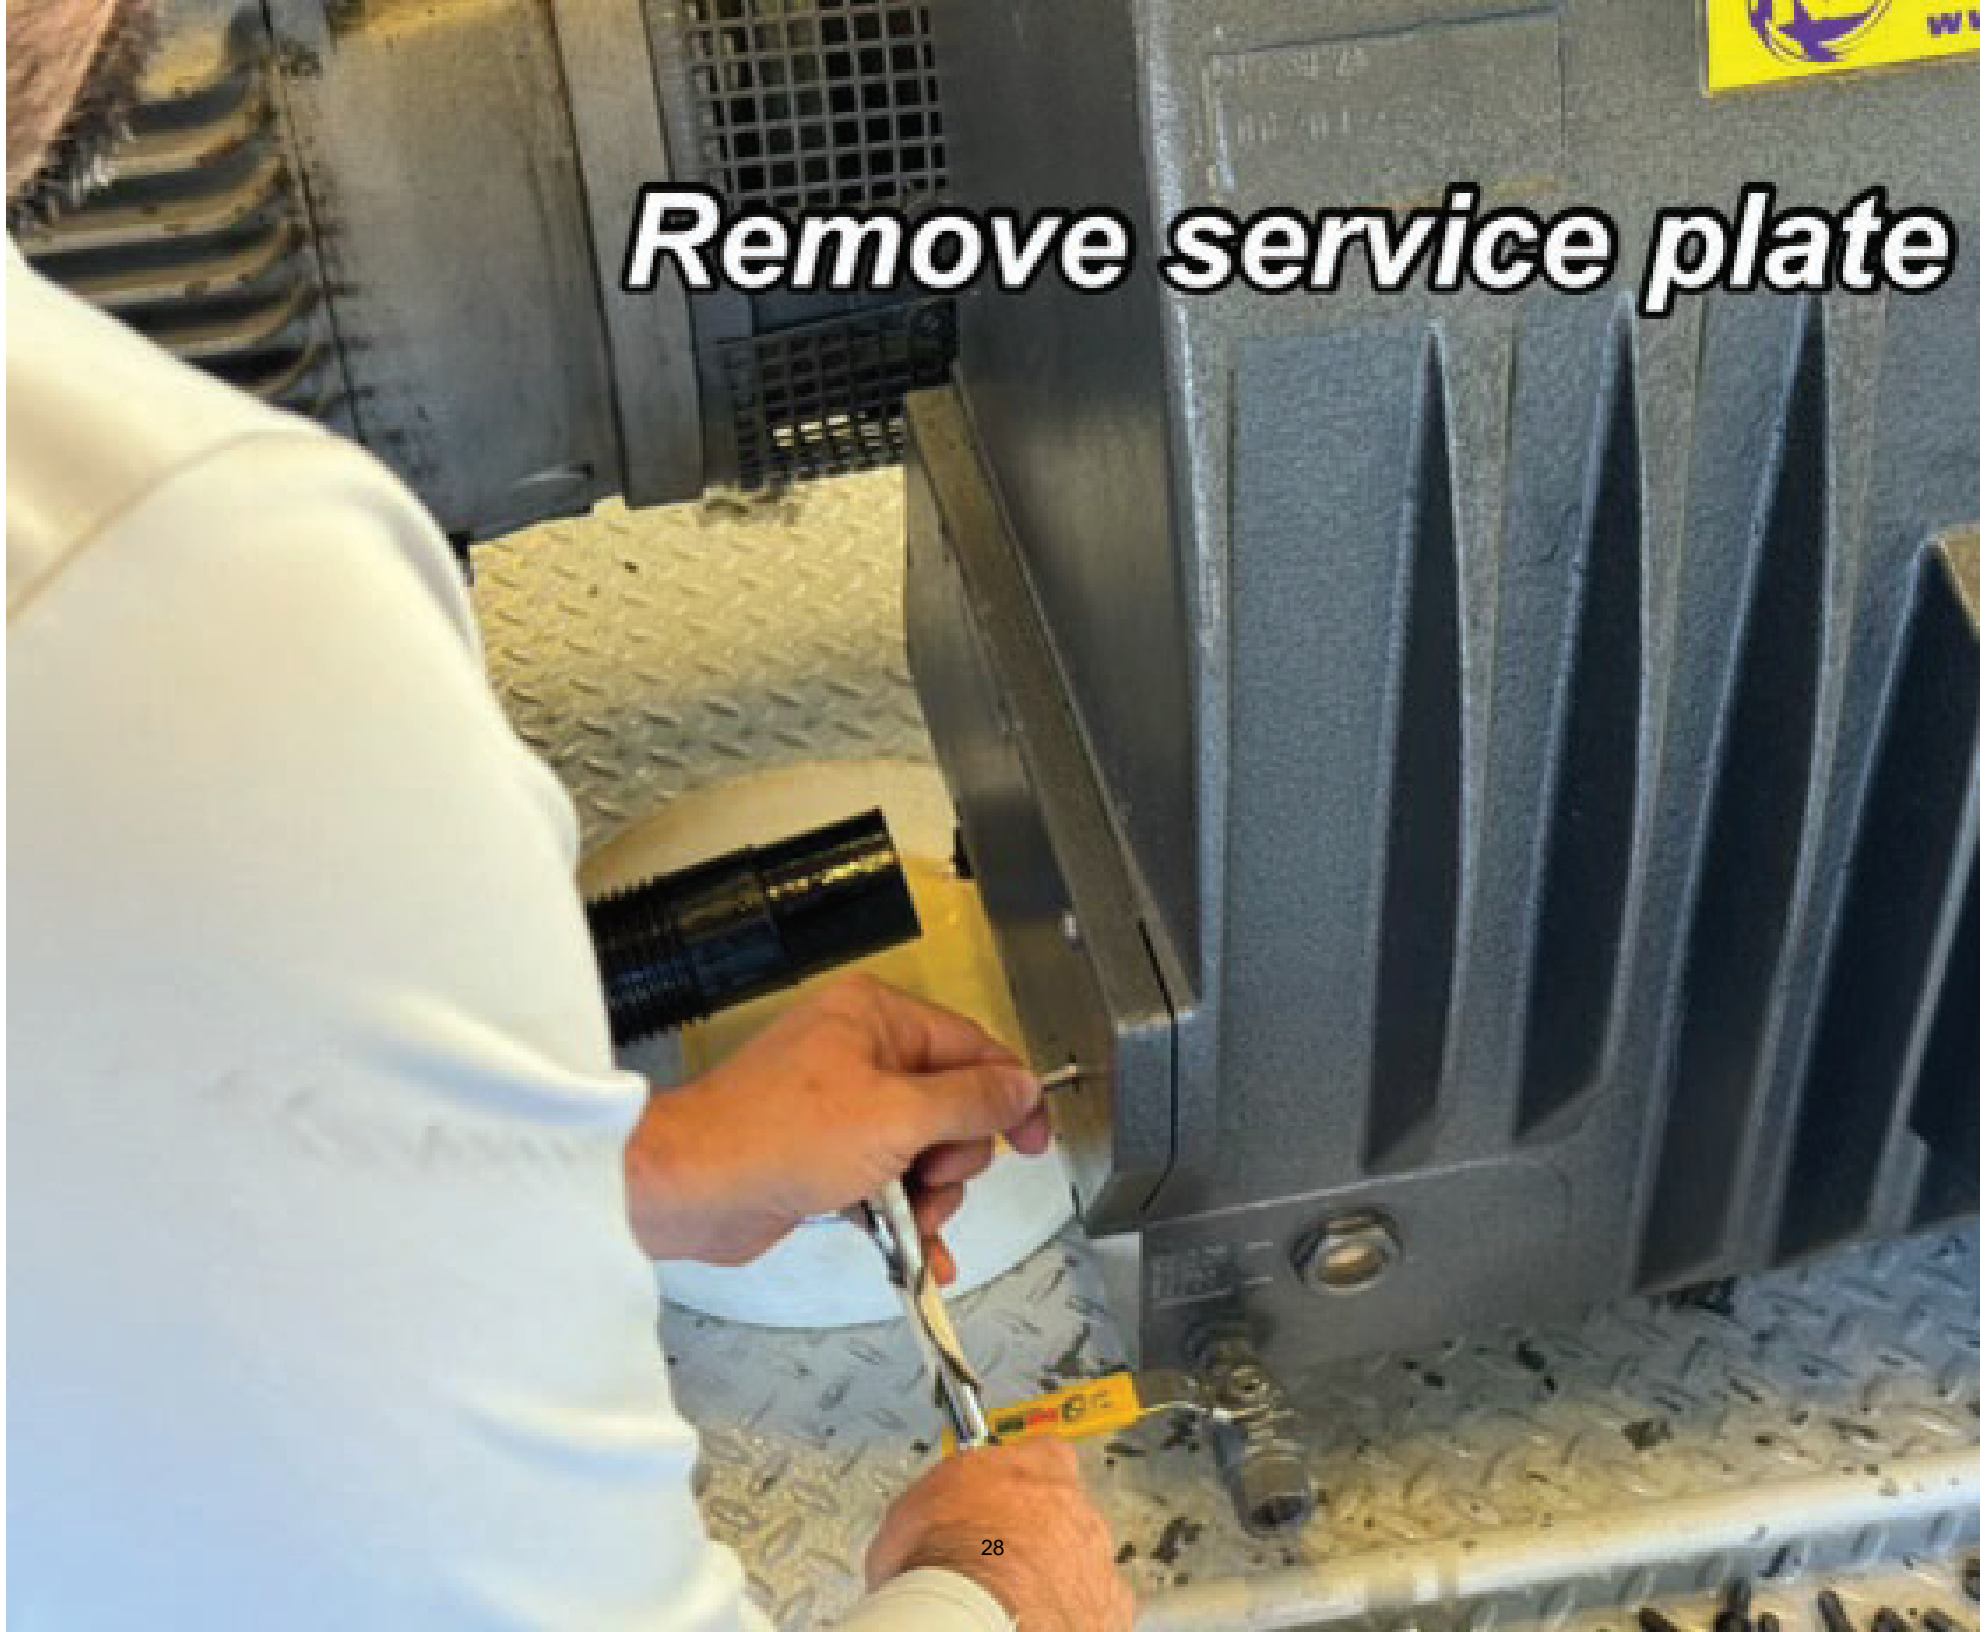
***Inspect gasket***  
***Inspect helicoils***

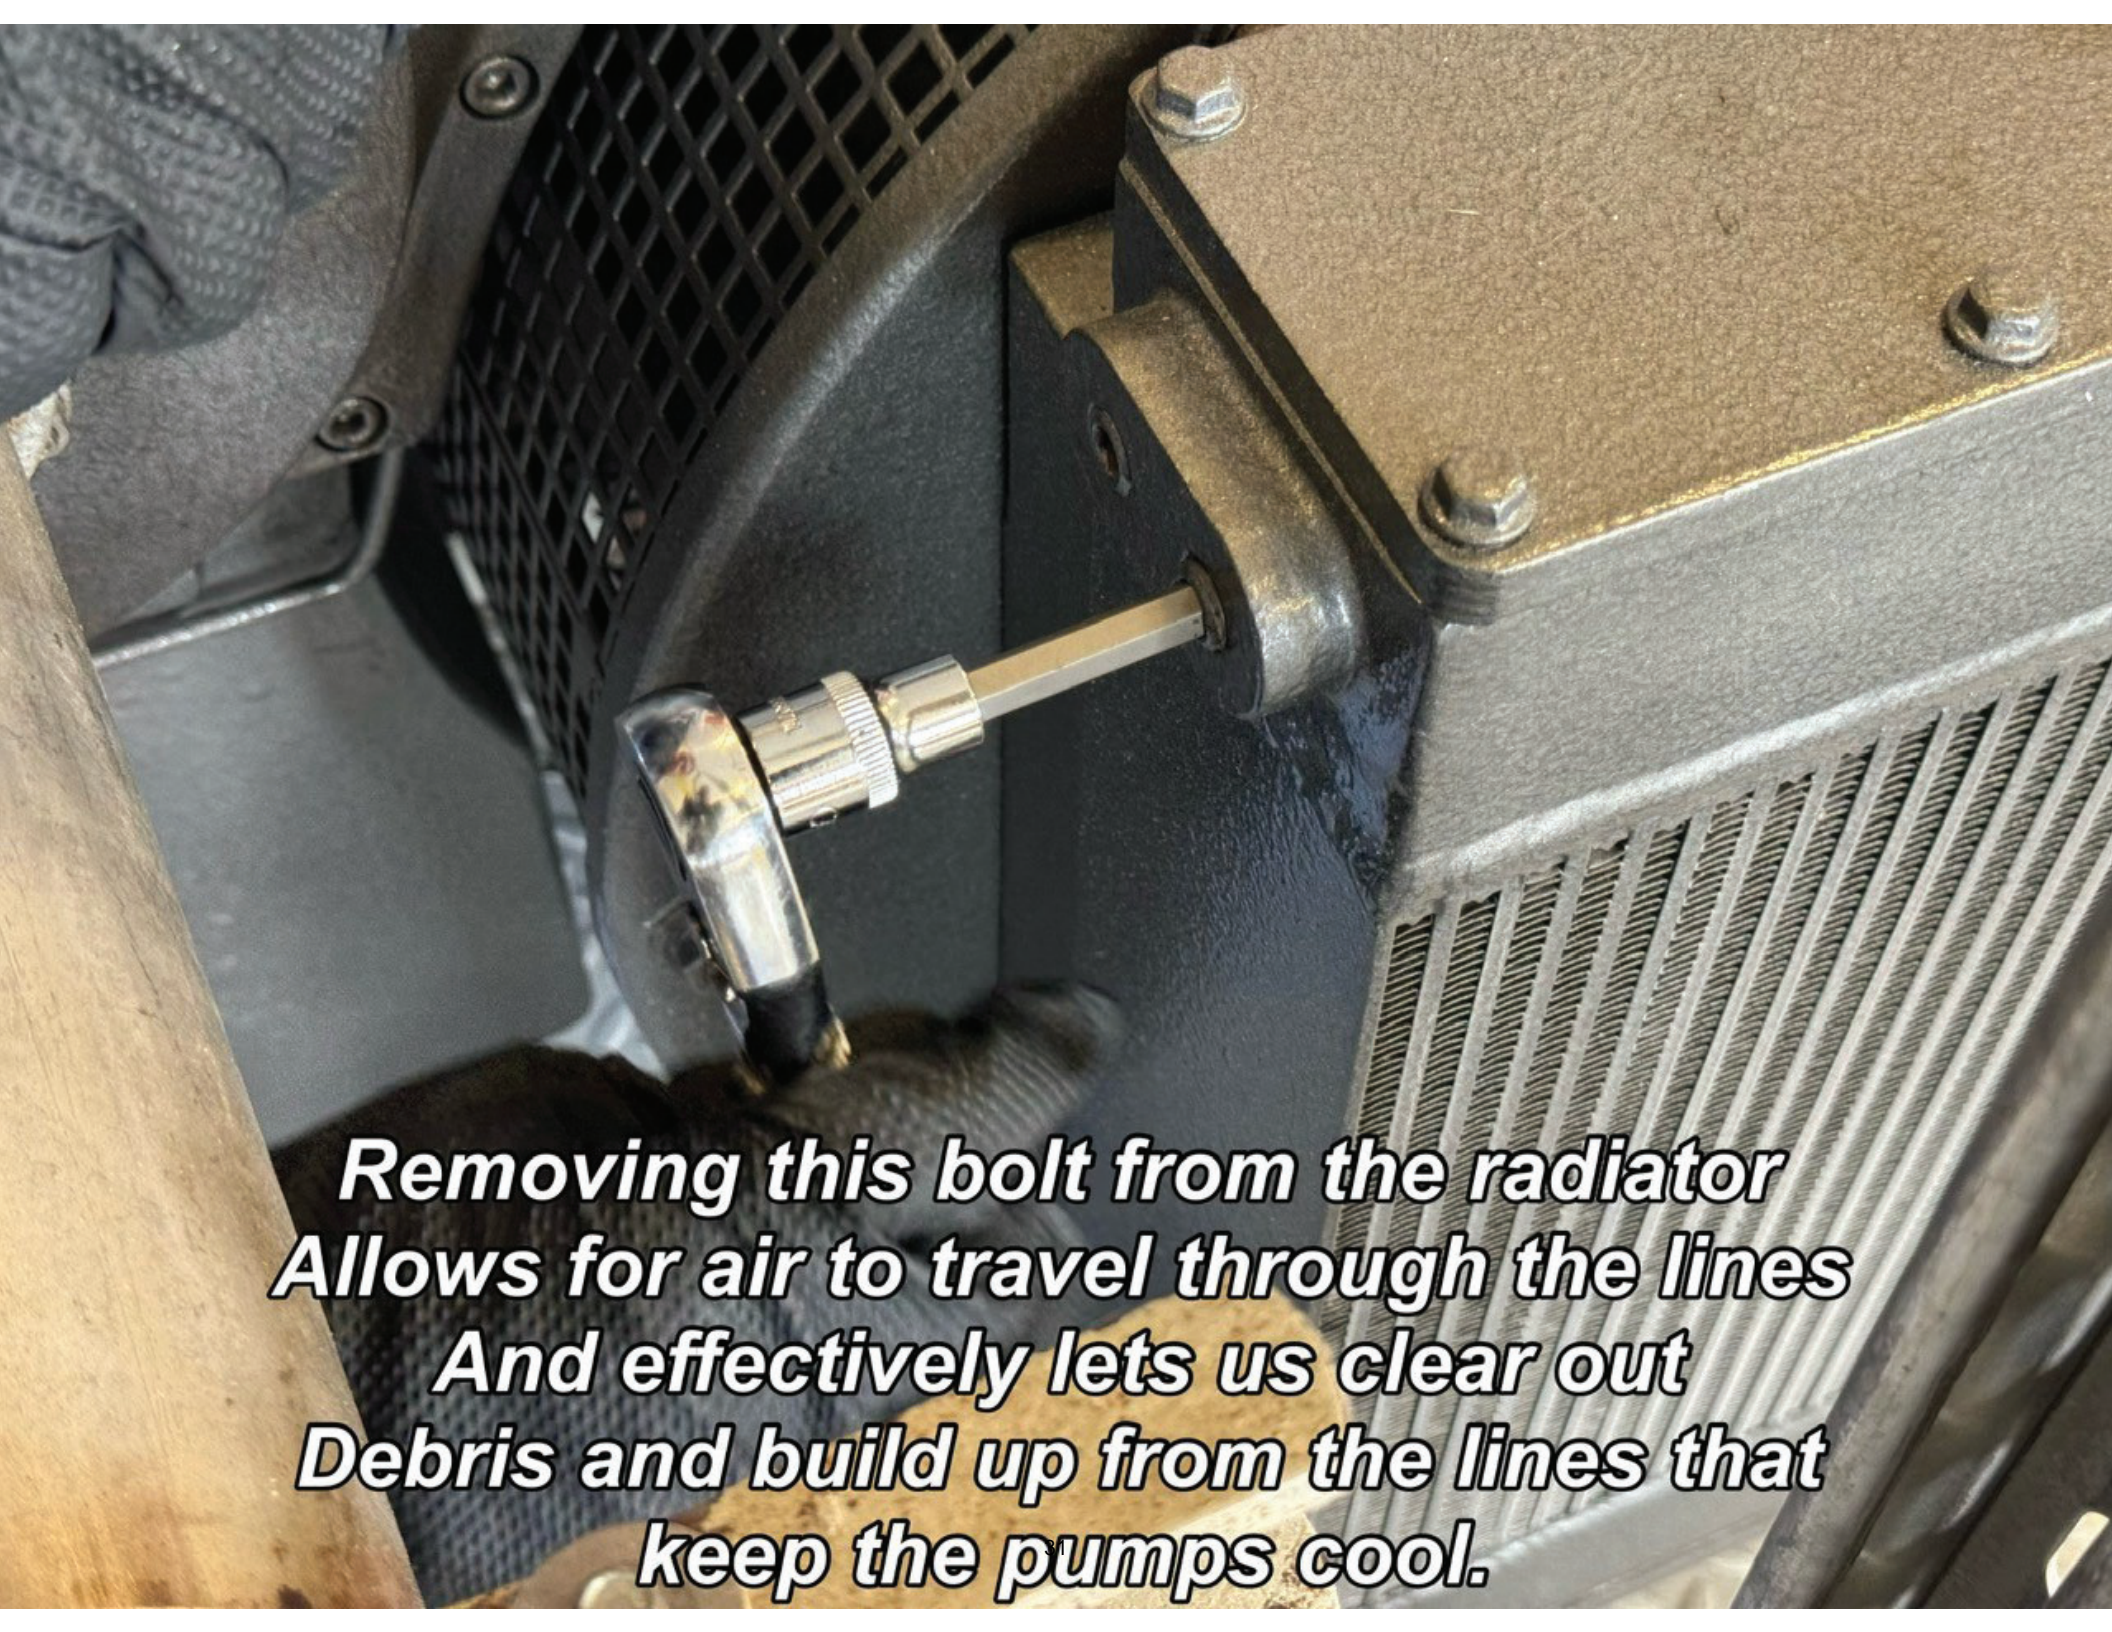
***Removing this bolt from the radiator  
Allows for air to travel through the lines  
And effectively lets us clear out  
Debris and build up from the lines that  
keep the pumps cool.***

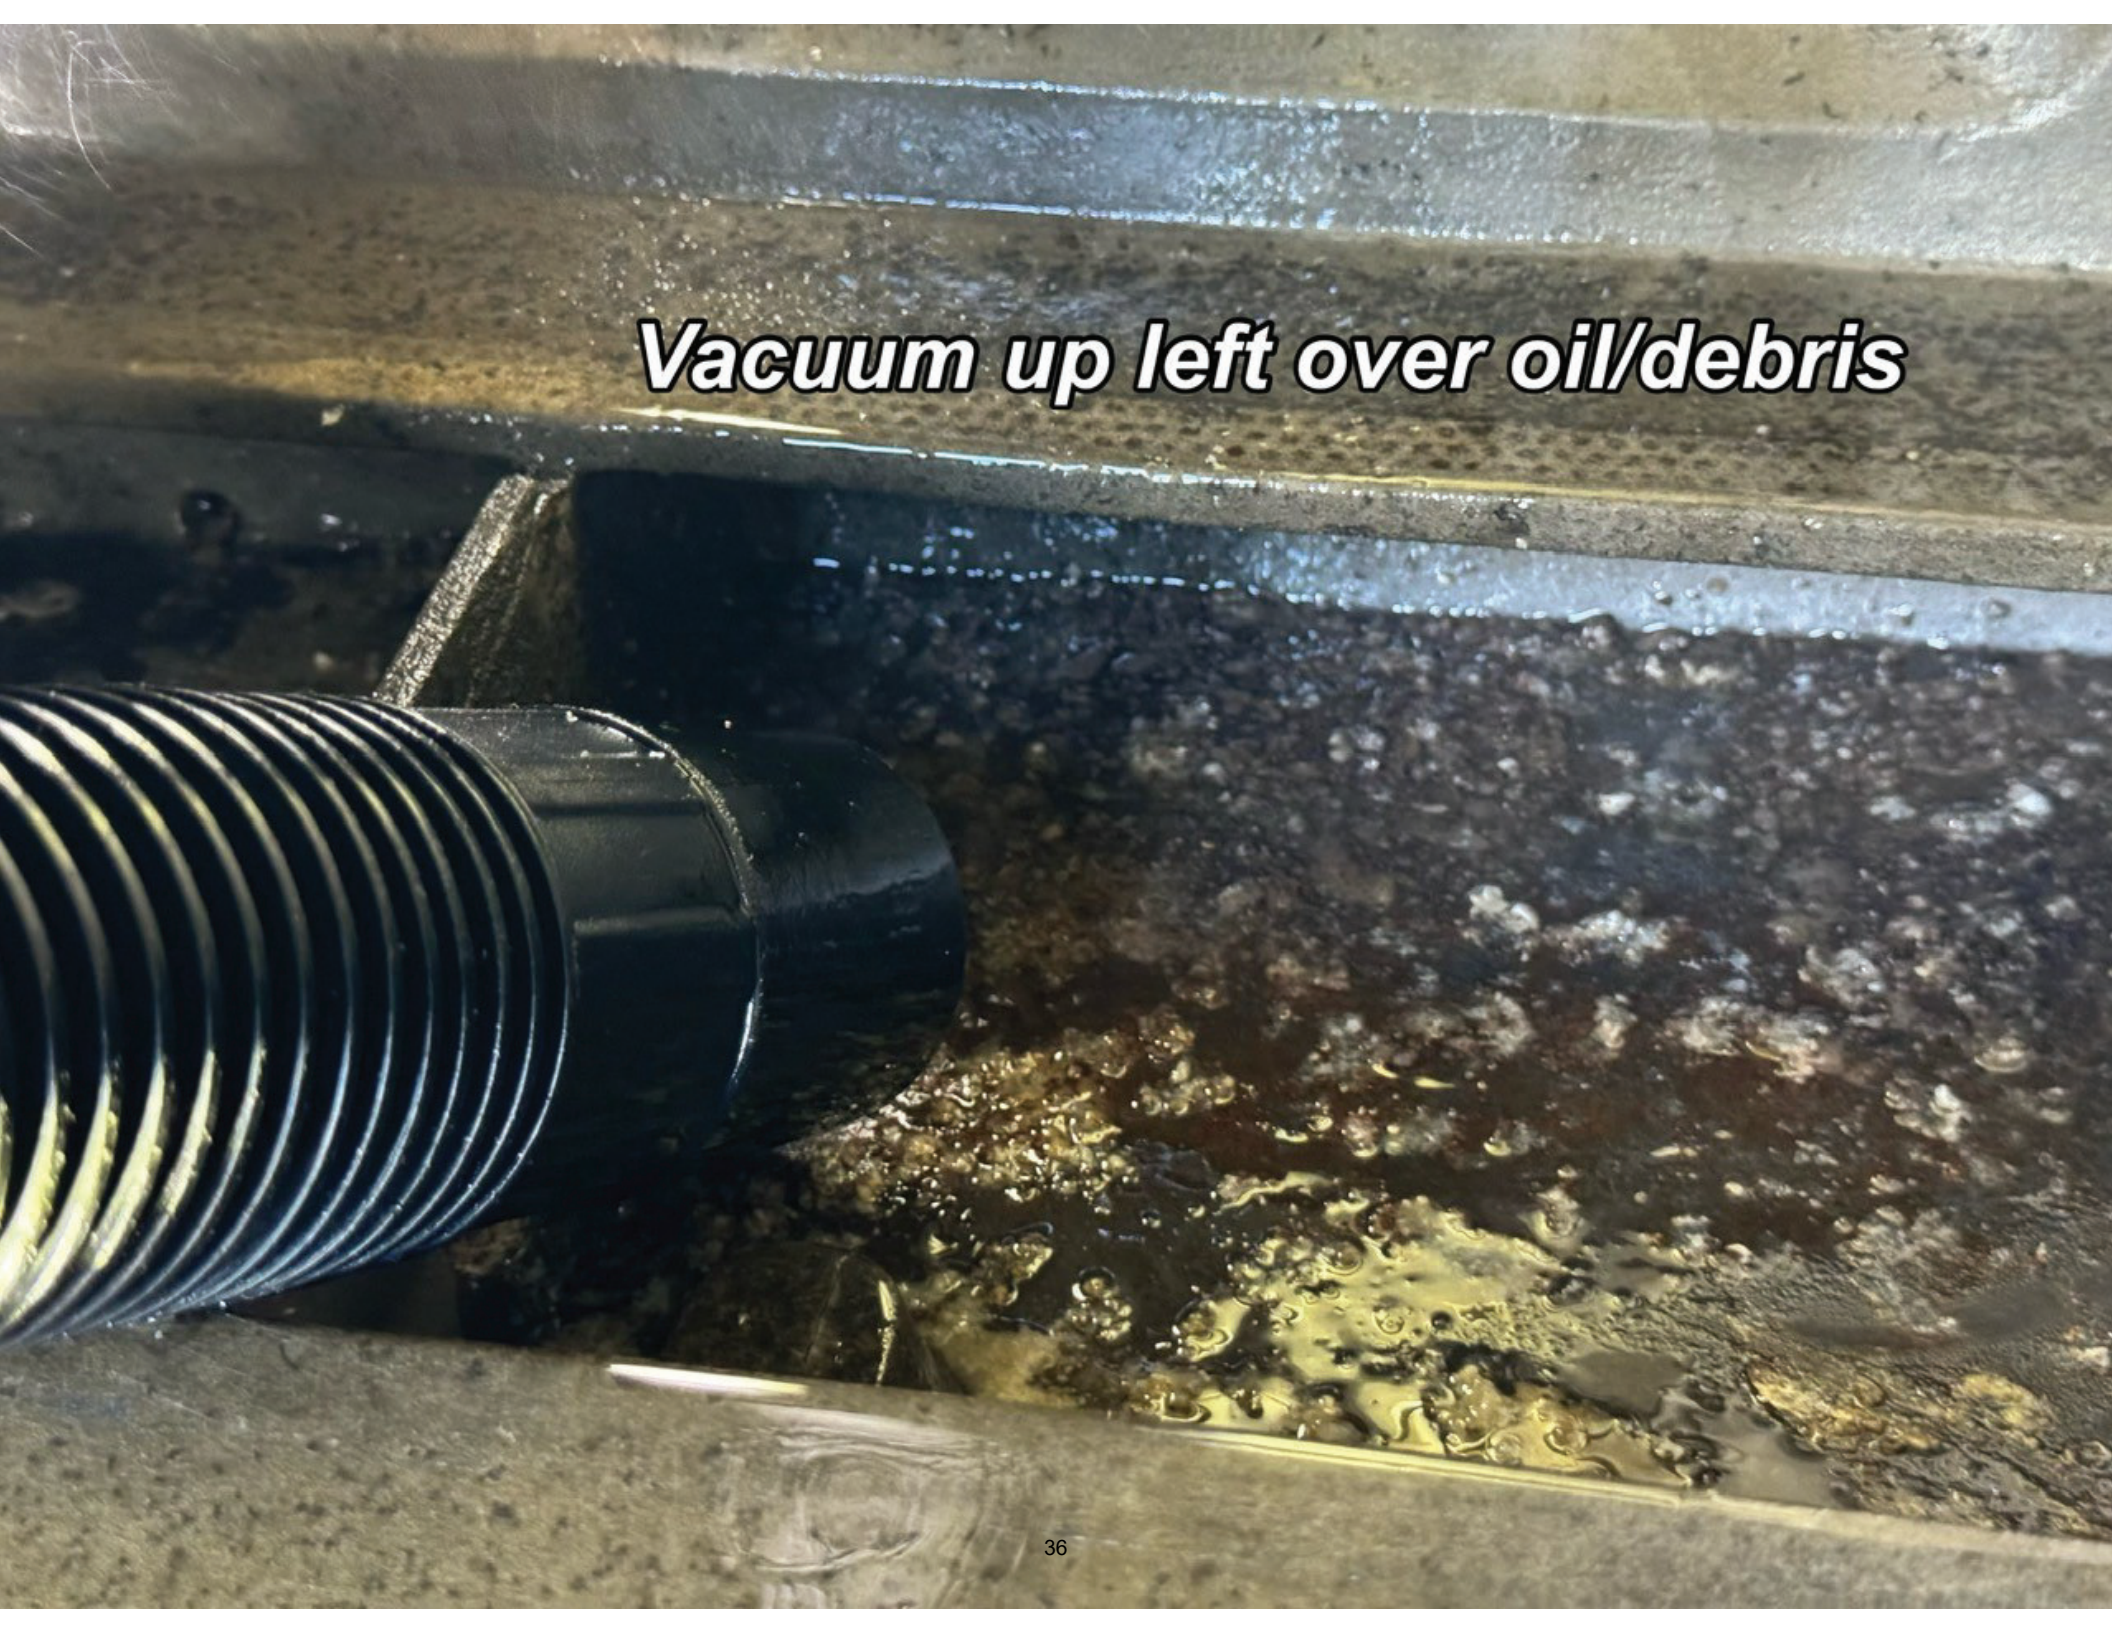
***Clean and inspect inside the pump.  
Making sure there isn't any debris, build up or old oil left behind.***

***Vacuum up left over oil/debris***

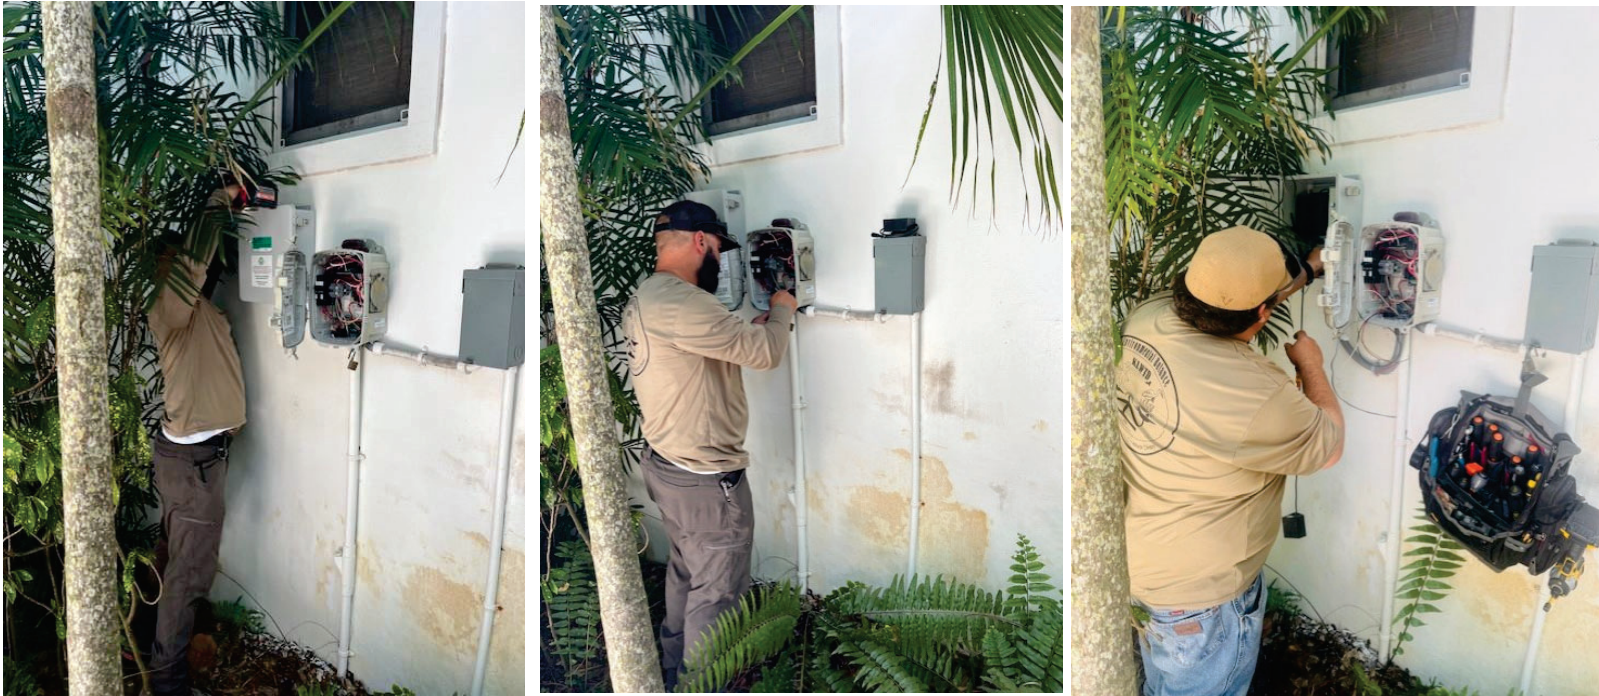
Installation of the Low Pressure Monitoring by Field Staff at 95450 Overseas Hwy

The Low Pressure Monitoring helps provide field staff monitor KLWTD's , Unique Grinder Pump Program. Gives us access to monitor the activations, runtimes and alarms.
