# Key Largo Wastewater Treatment District Board of Commissioners Meeting Agenda Item Summary

**Plant/Facilities Report - July 2025**

## Wastewater Treatment Plant Operations

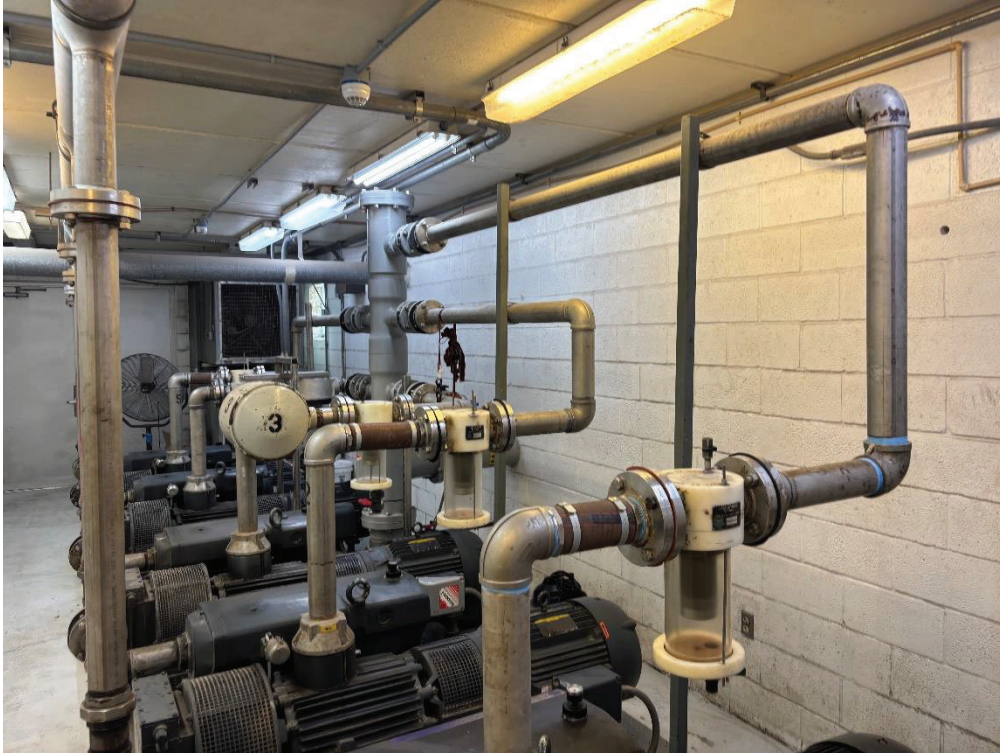
Figure 1: Vacuum station E before

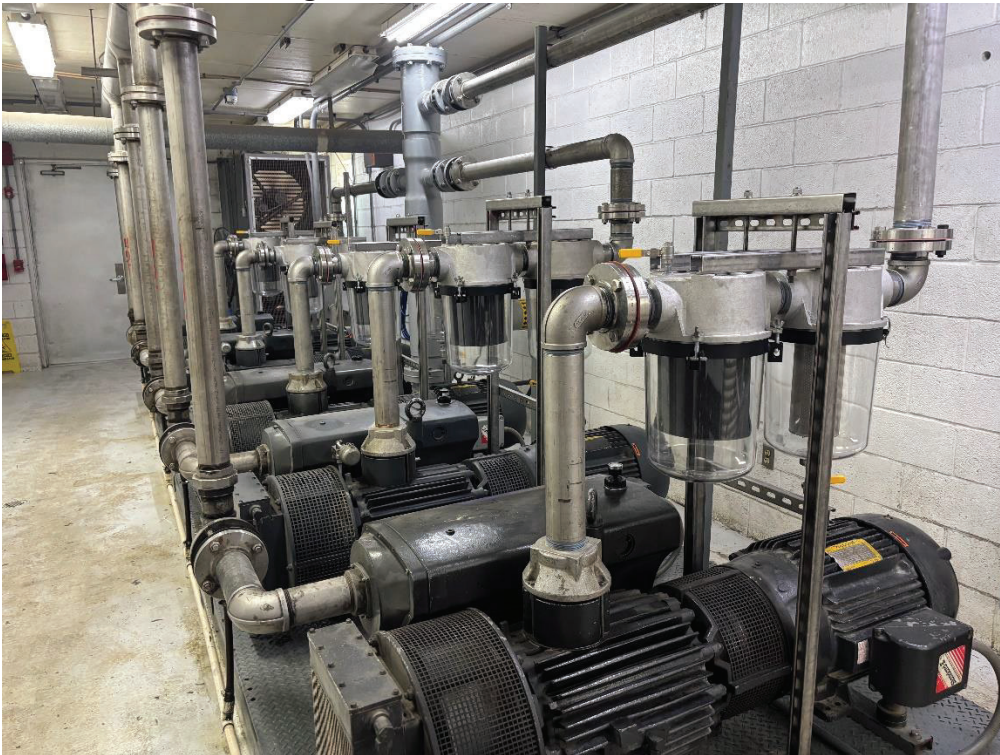
Figure 2: Vacuum station E with all new pump filters and support brackets installed

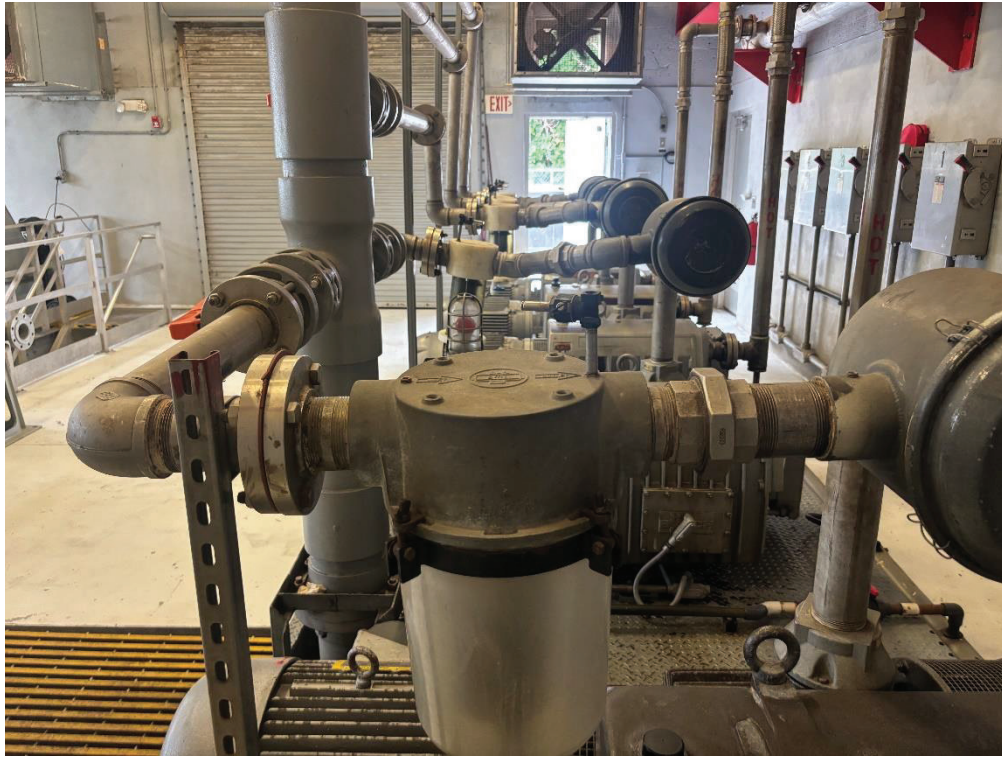
**Figure 3: Vacuum station D Before**

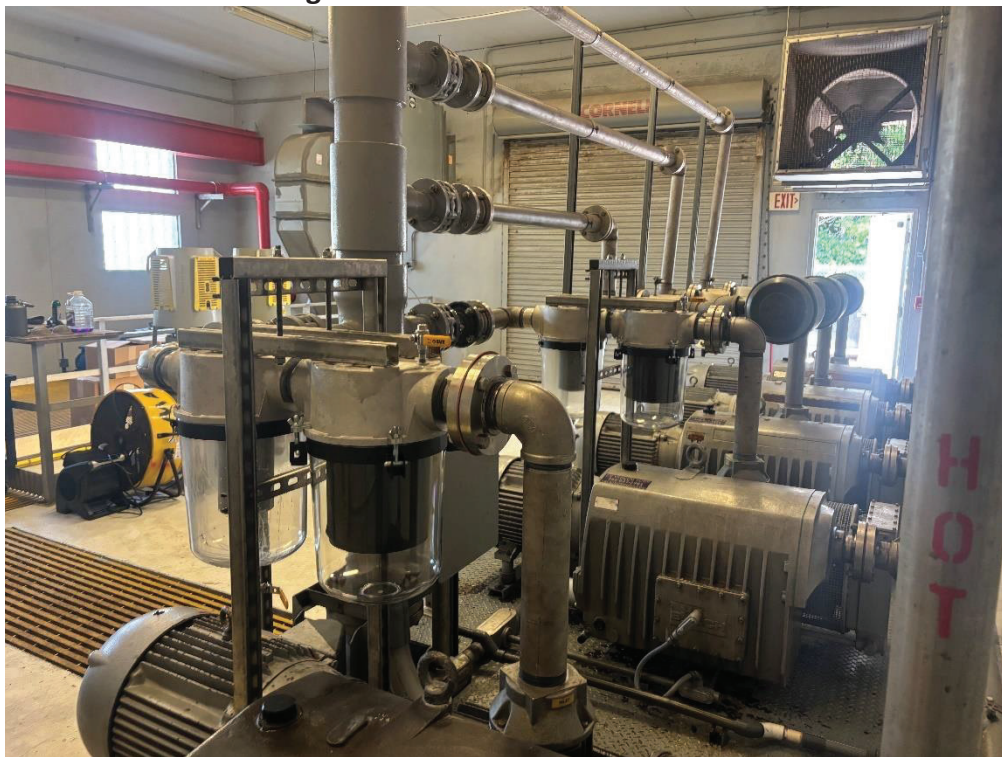
**Figure 4: Vacuum station D 2 of 5 pump filters complete**

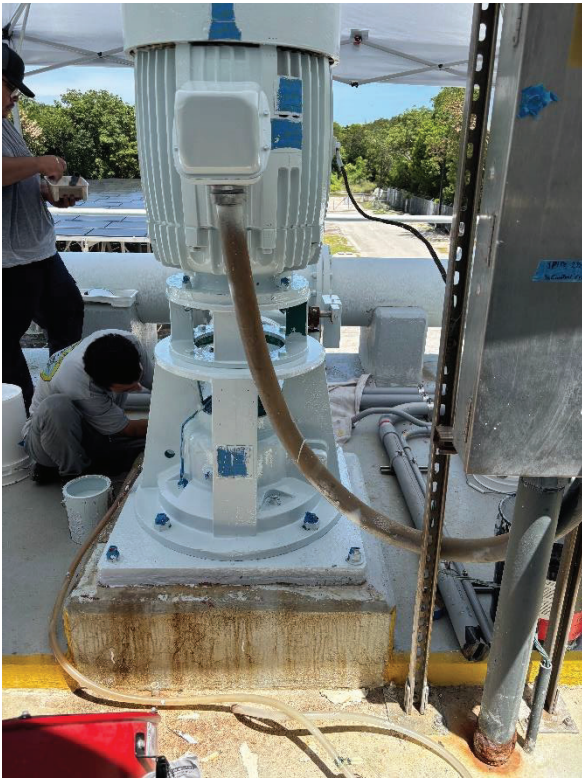
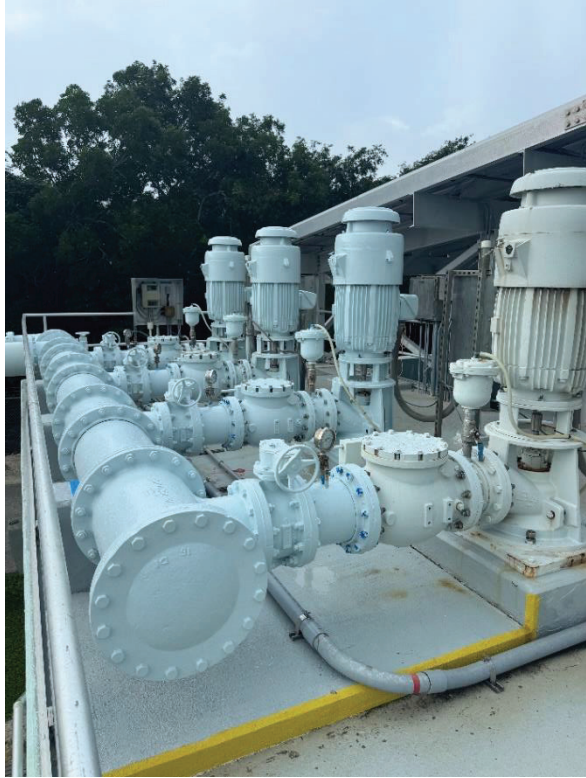
Figures 5 and 6: Injection well pumps treated and painted.

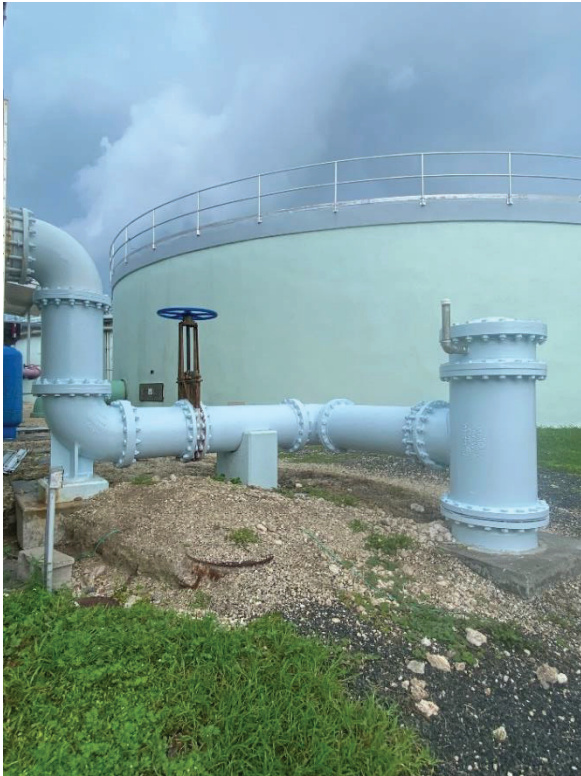
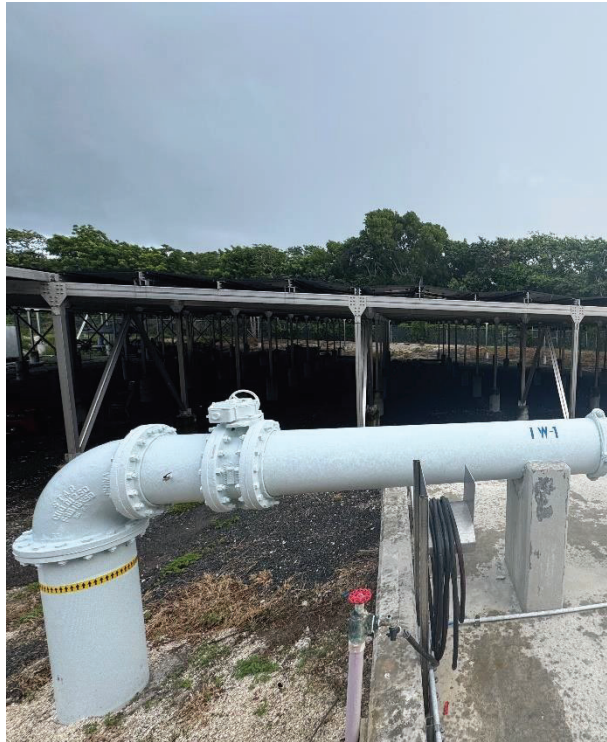
Figures 7 and 8: Well piping treated and painted.

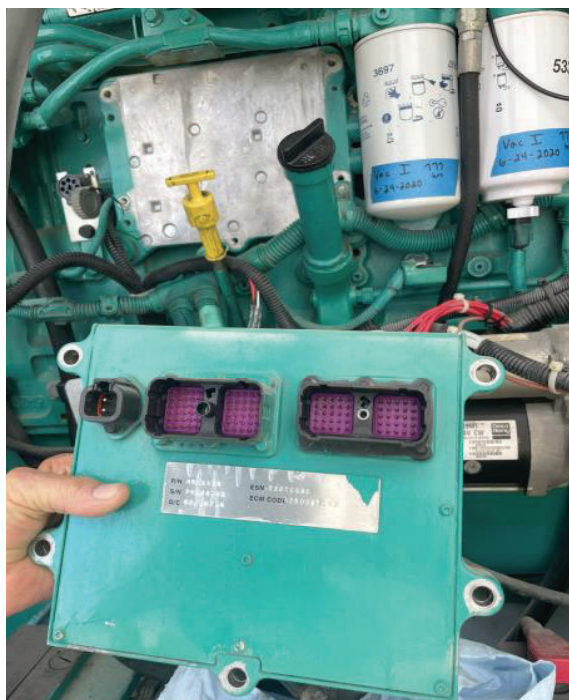
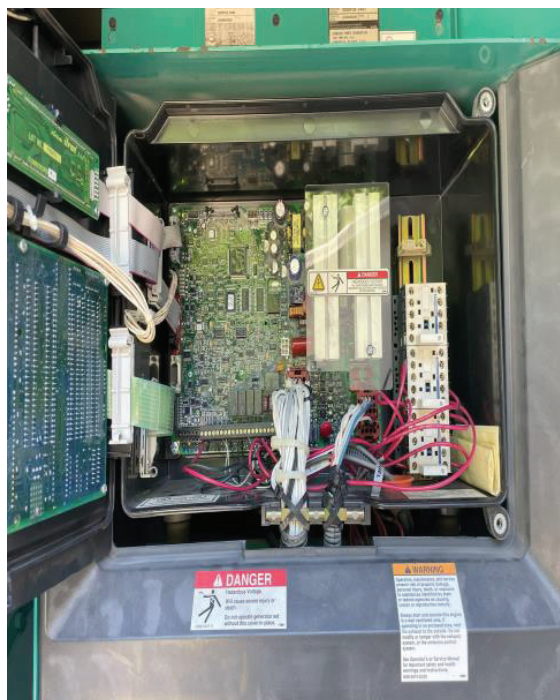
Figures 9 and 10: Vacuum station I backup generator ECU repair

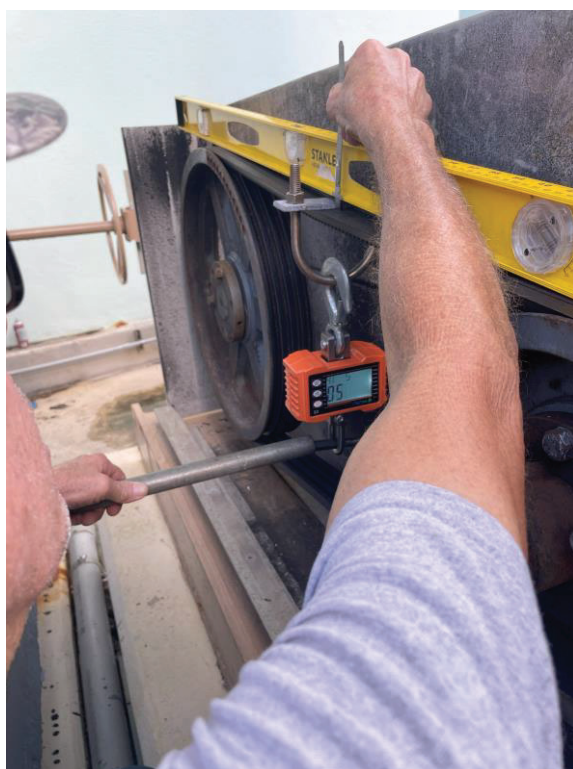
Figure 11: Digester motive pump belt adjustment.
