# Key Largo Wastewater Treatment District Board of Commissioners Meeting Agenda Item Summary

**Field Report - August 2026**

## Wastewater Field Operations

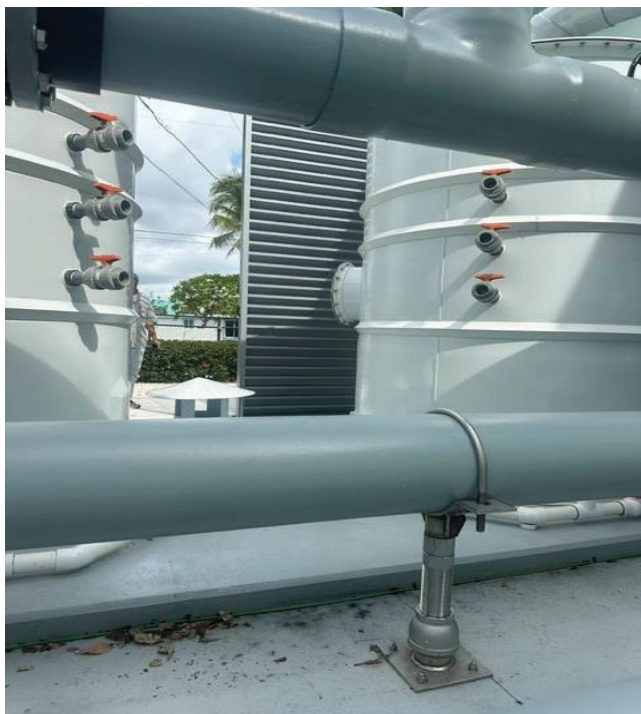
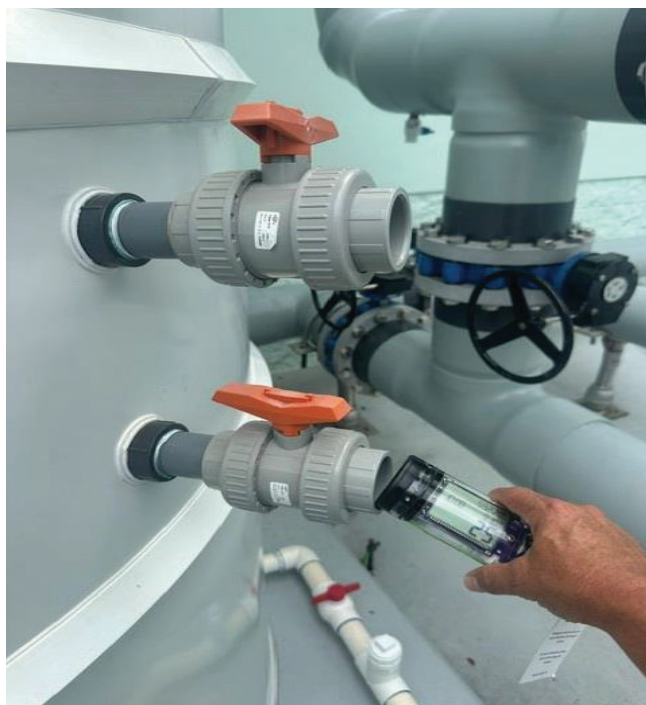
Lower port testing 25 ppm

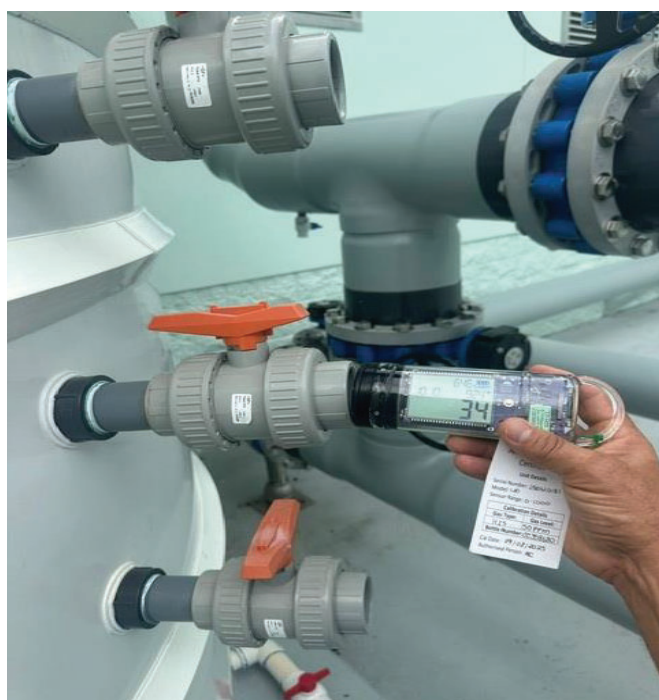
Middle port test 34 ppm

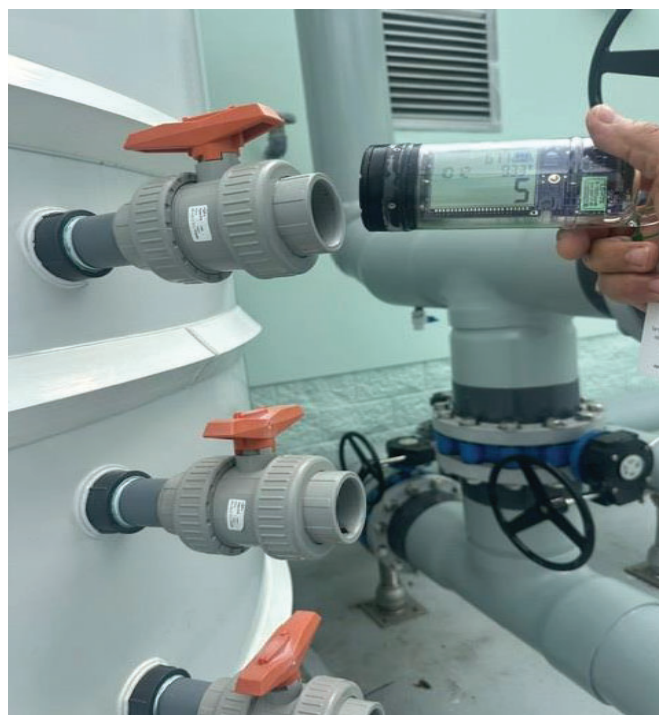
Upper port test 5 ppm

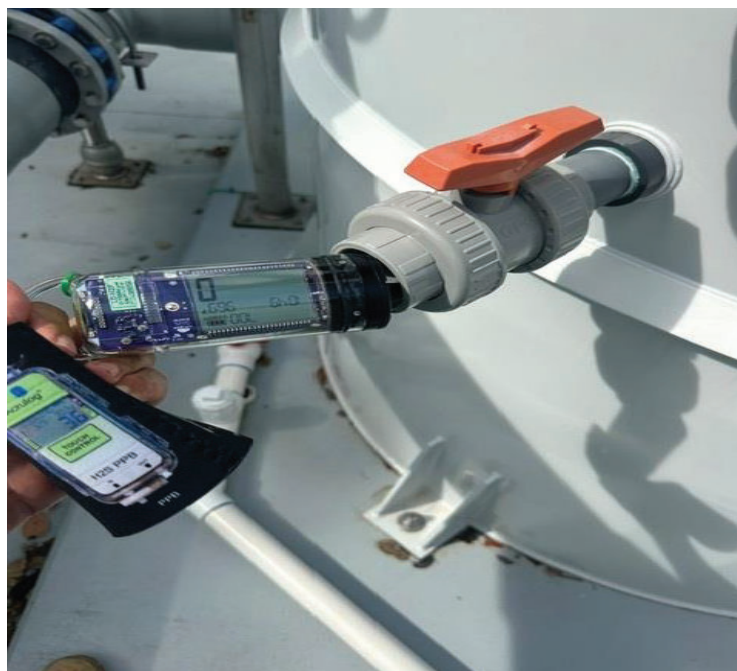
Lower port on in - sink chamber showing 0 ppm
