# Key Largo Wastewater Treatment District Board of Commissioners Meeting Agenda Item Summary

**Plant/Facilities Report - October 2025**

# Wastewater Treatment Plant Operations

## Vac station I Sewage pump upgrade project

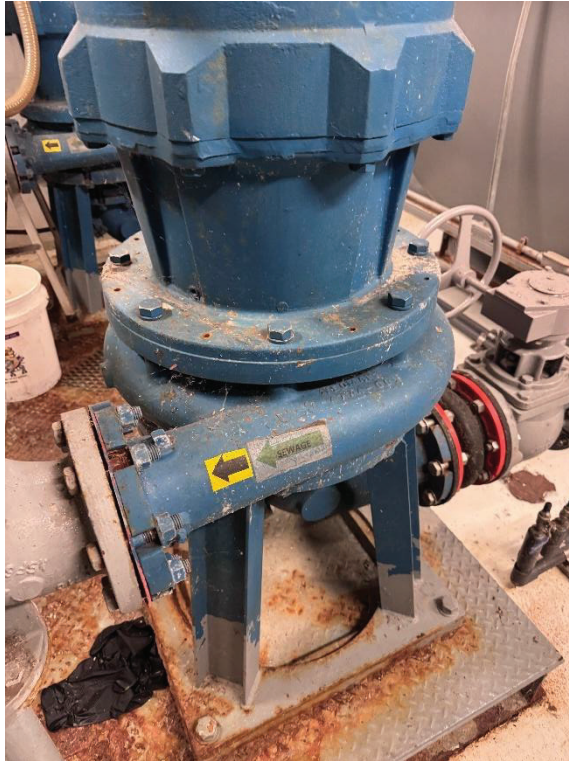
Figure 1: Old pump and rusted pump skid

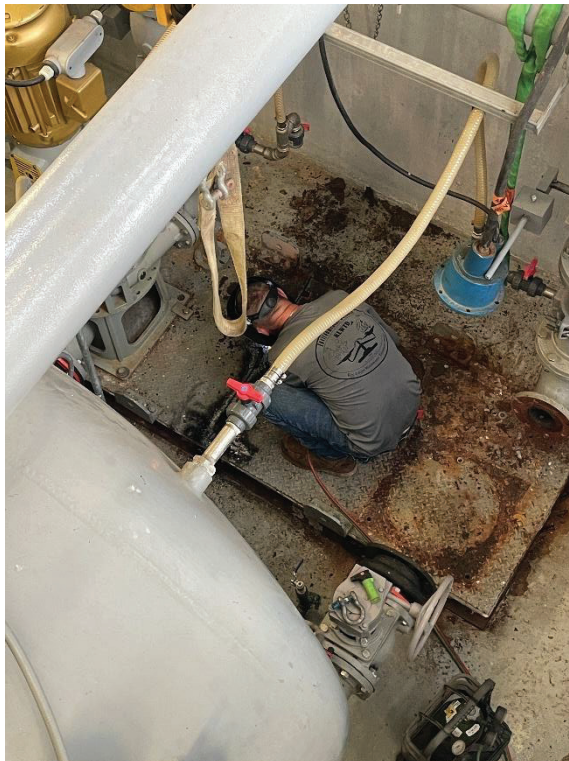
Figure 2: Pump removed and steel skid cutting

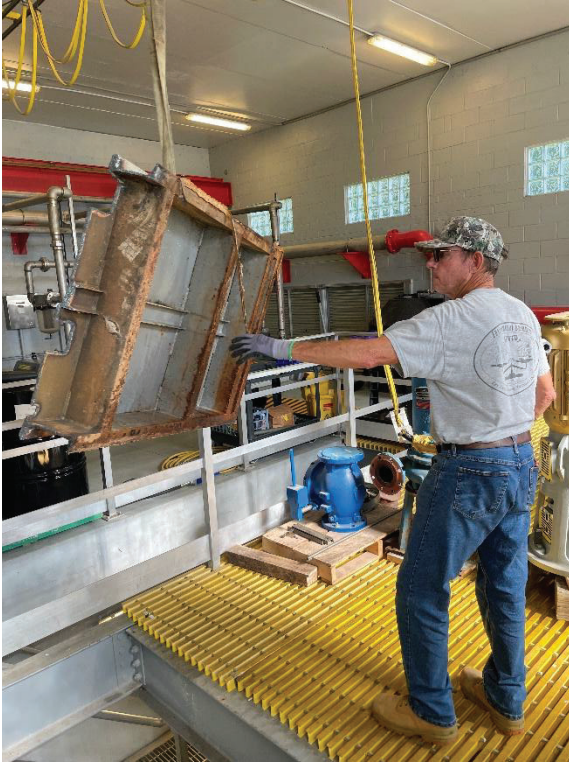
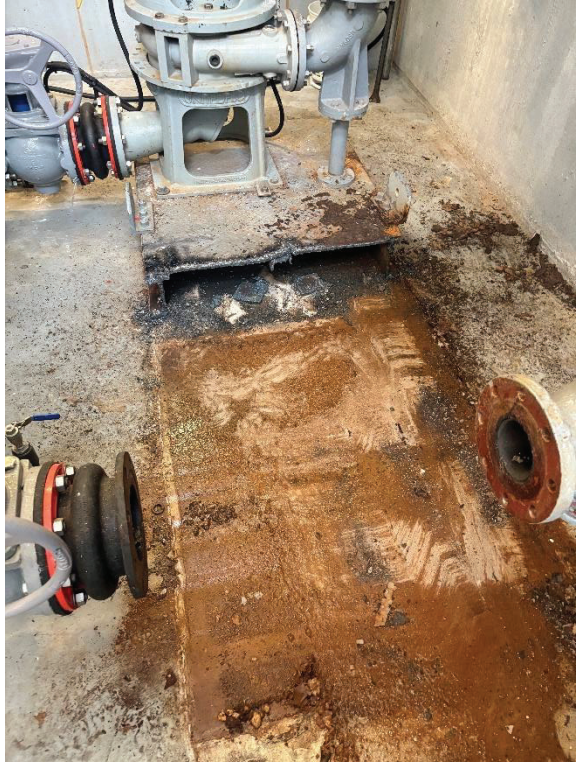
Figures 3 and 4: Steel skid removal

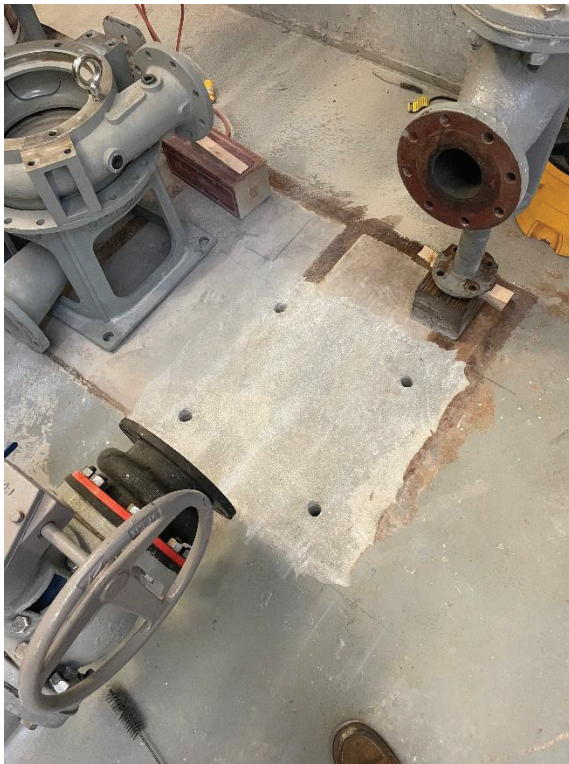
Figures 5 and 6: Grout base prep work

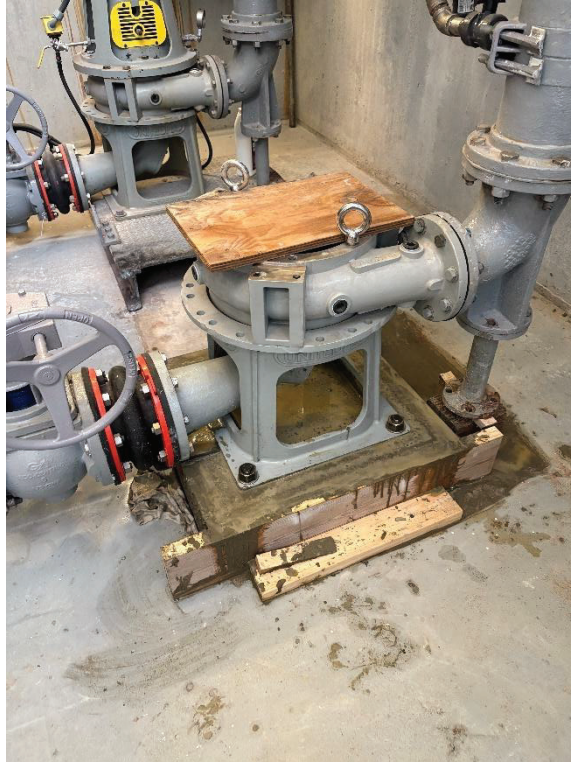
Figure 7: Grout pump base formed and poured

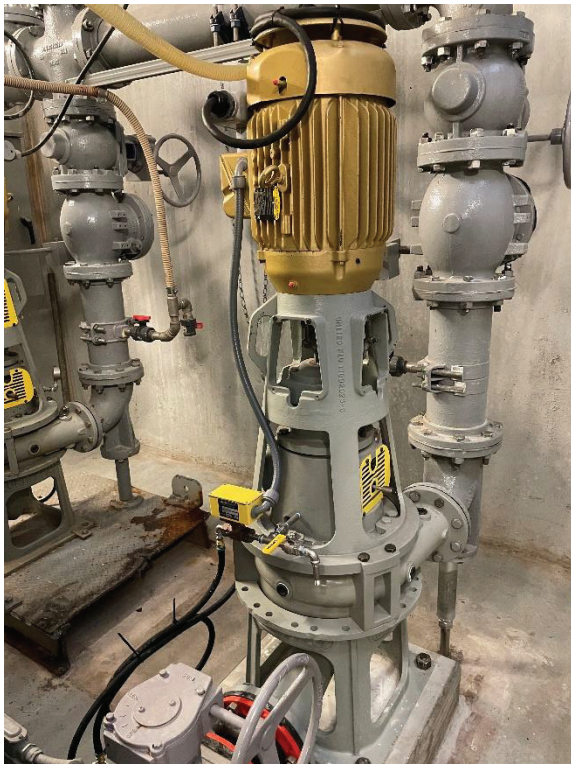
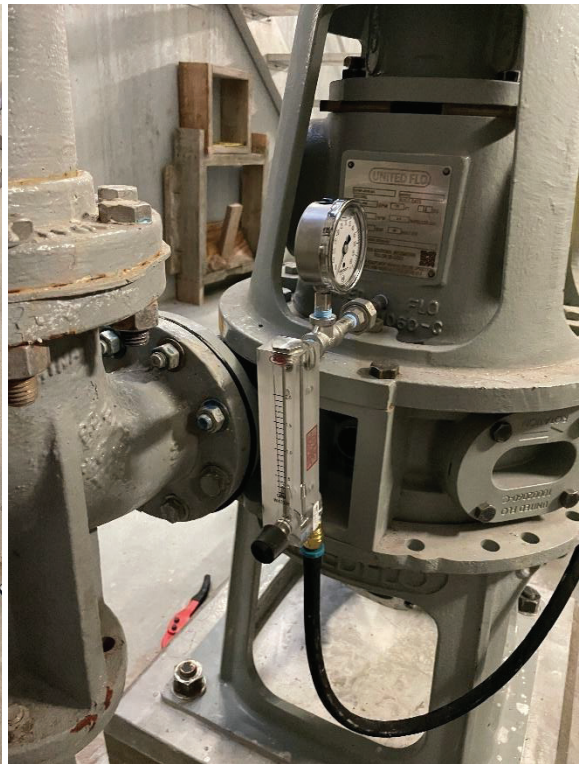
Figures 8 and 9: New pump installed, wired and seal water system plumbed.
