# Key Largo Wastewater Treatment District Board of Commissioners Meeting Agenda Item Summary

**Field Report - March 2025**

## Wastewater Field Operations

***3 month interval oil change process***

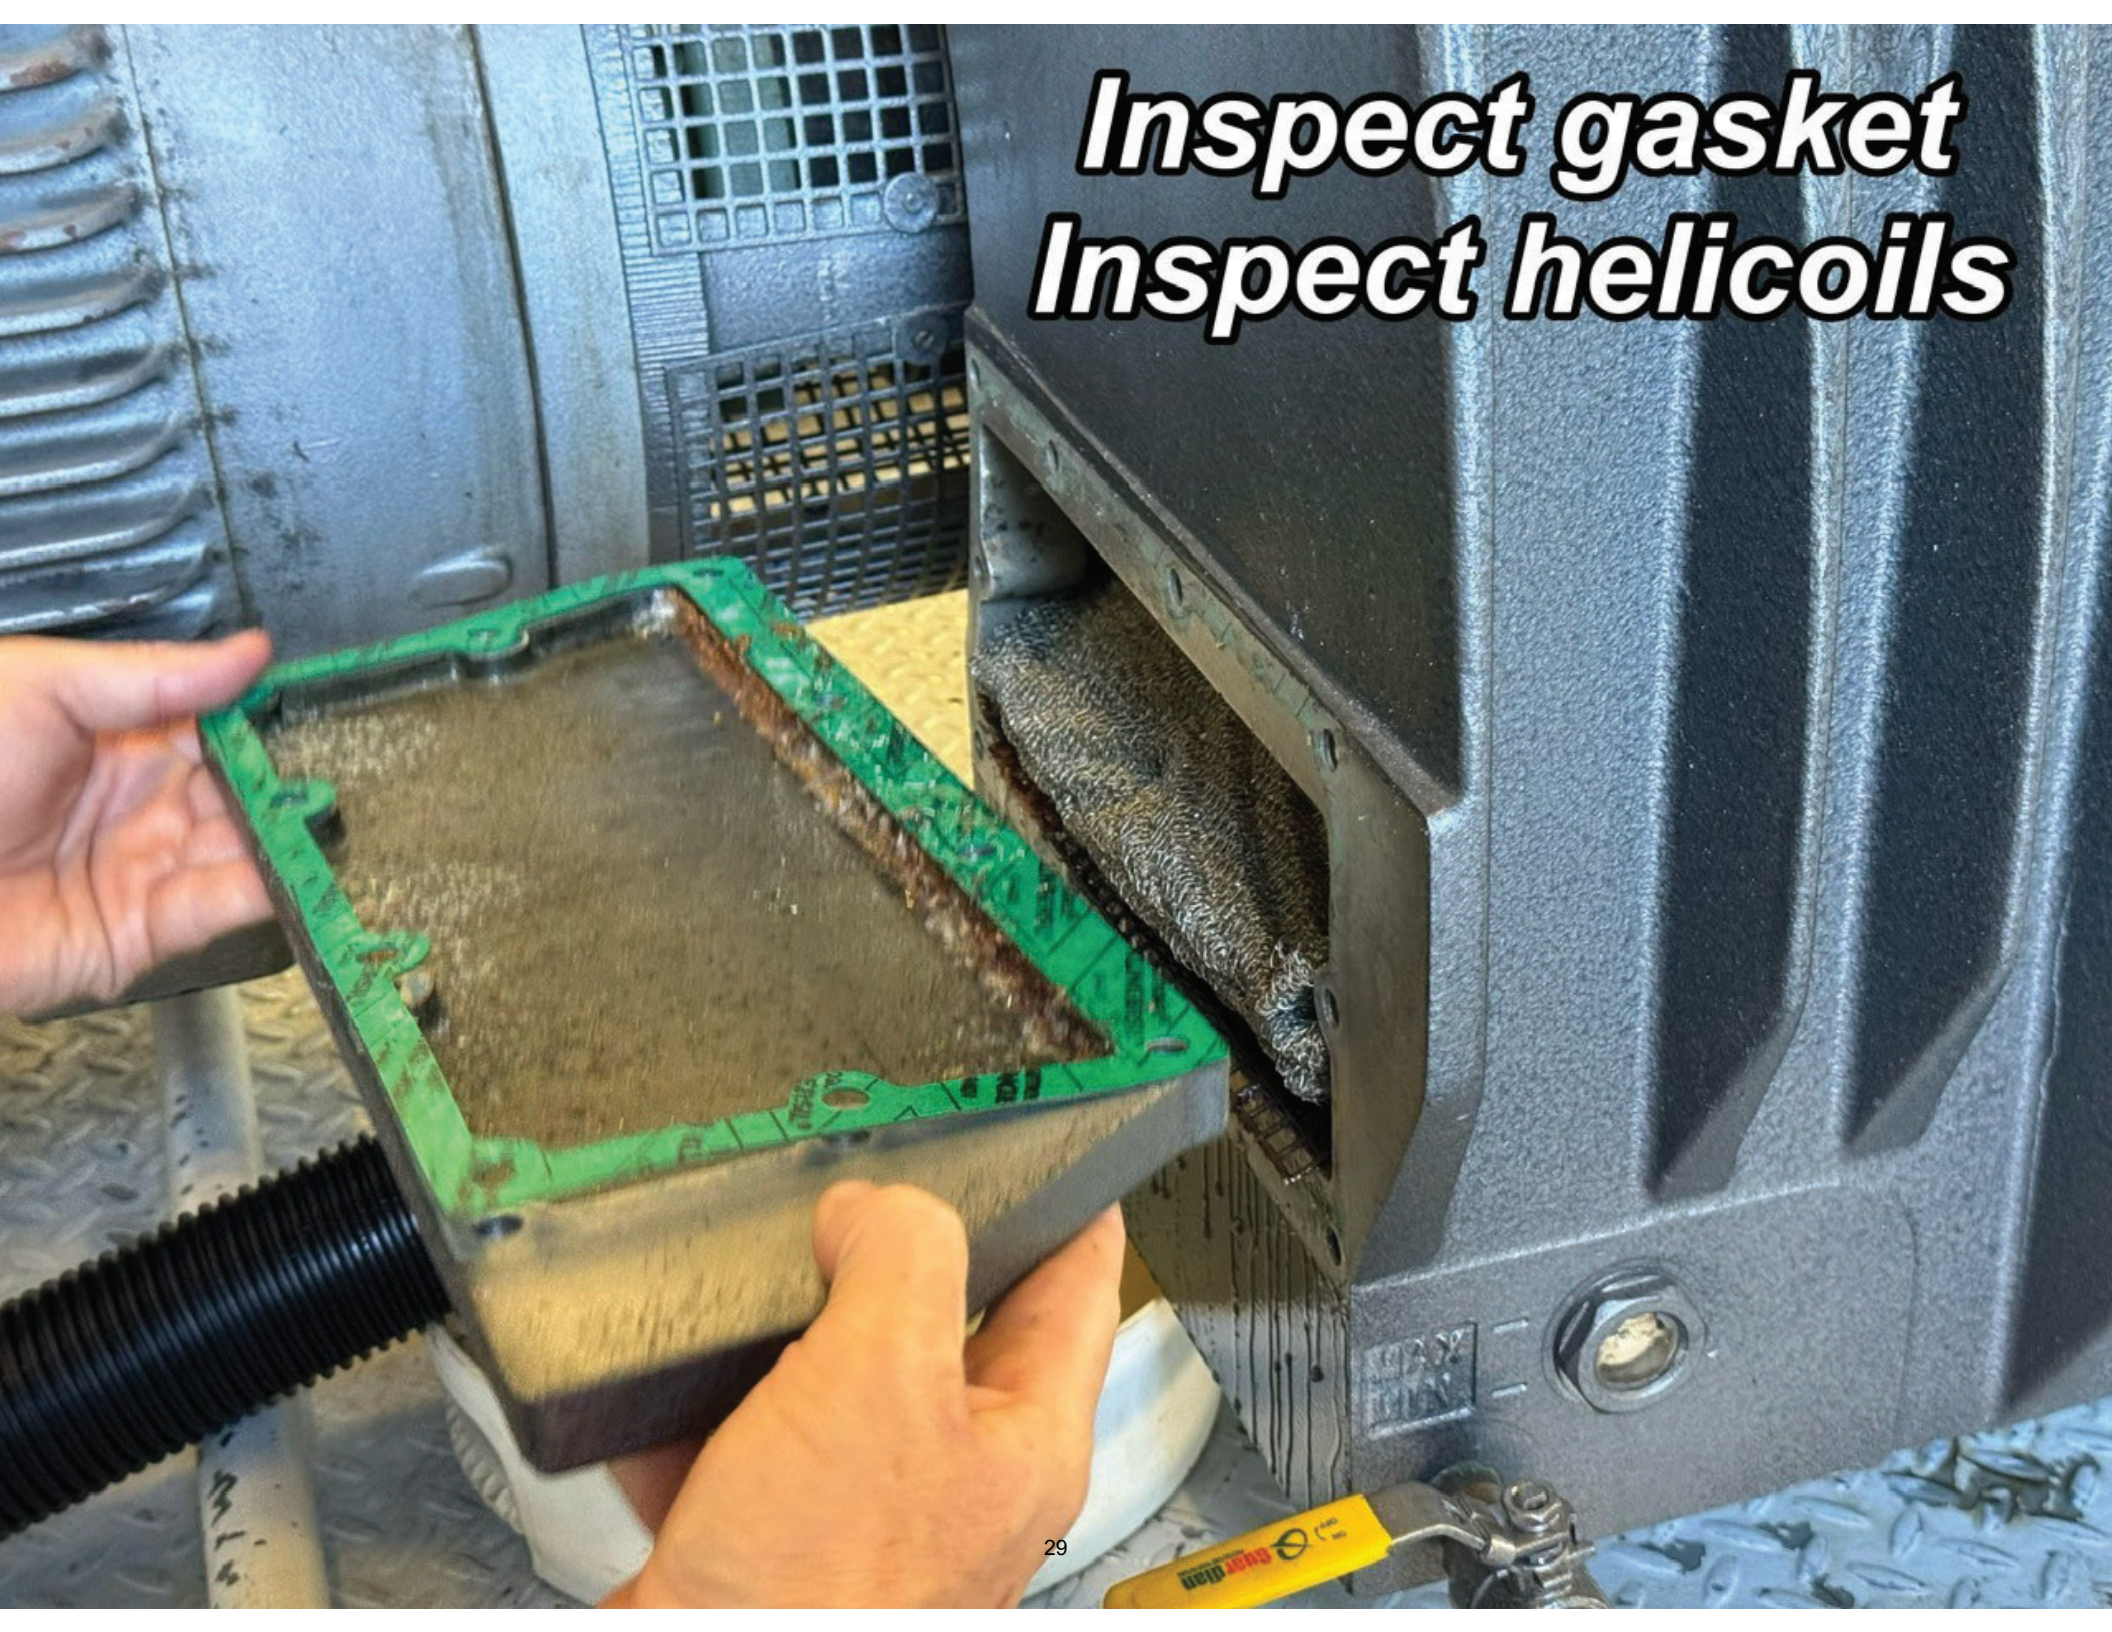
***Inspect gasket***  
***Inspect helicoils***

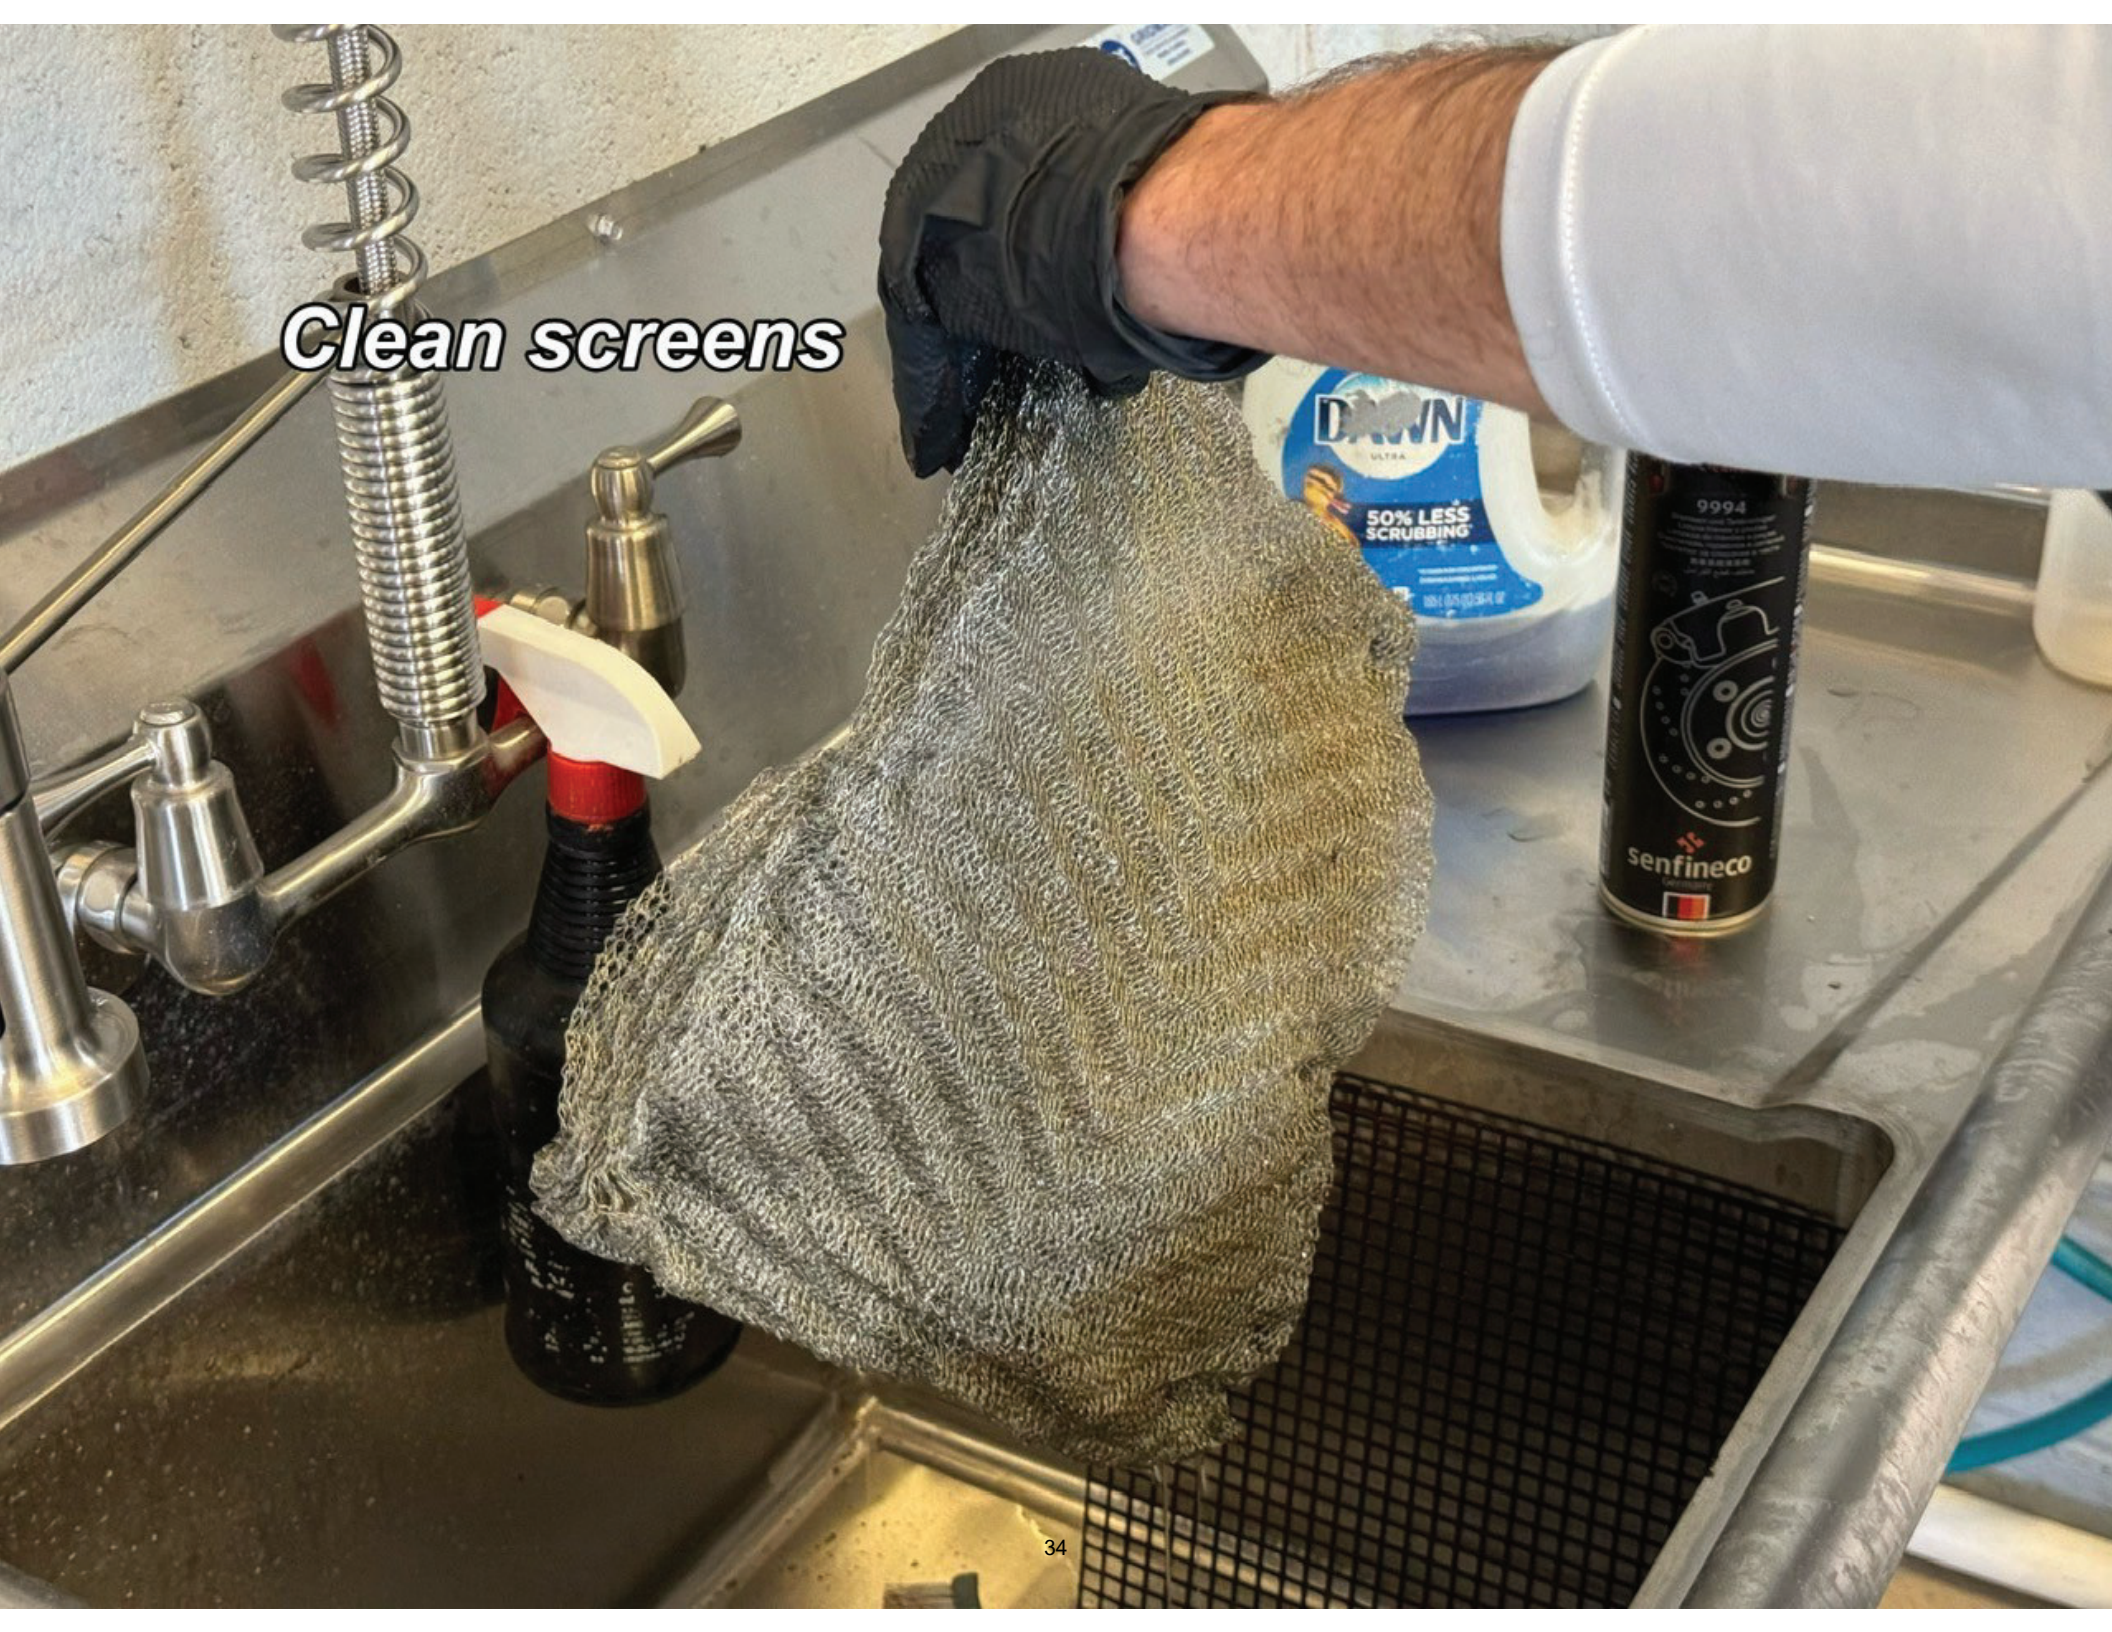
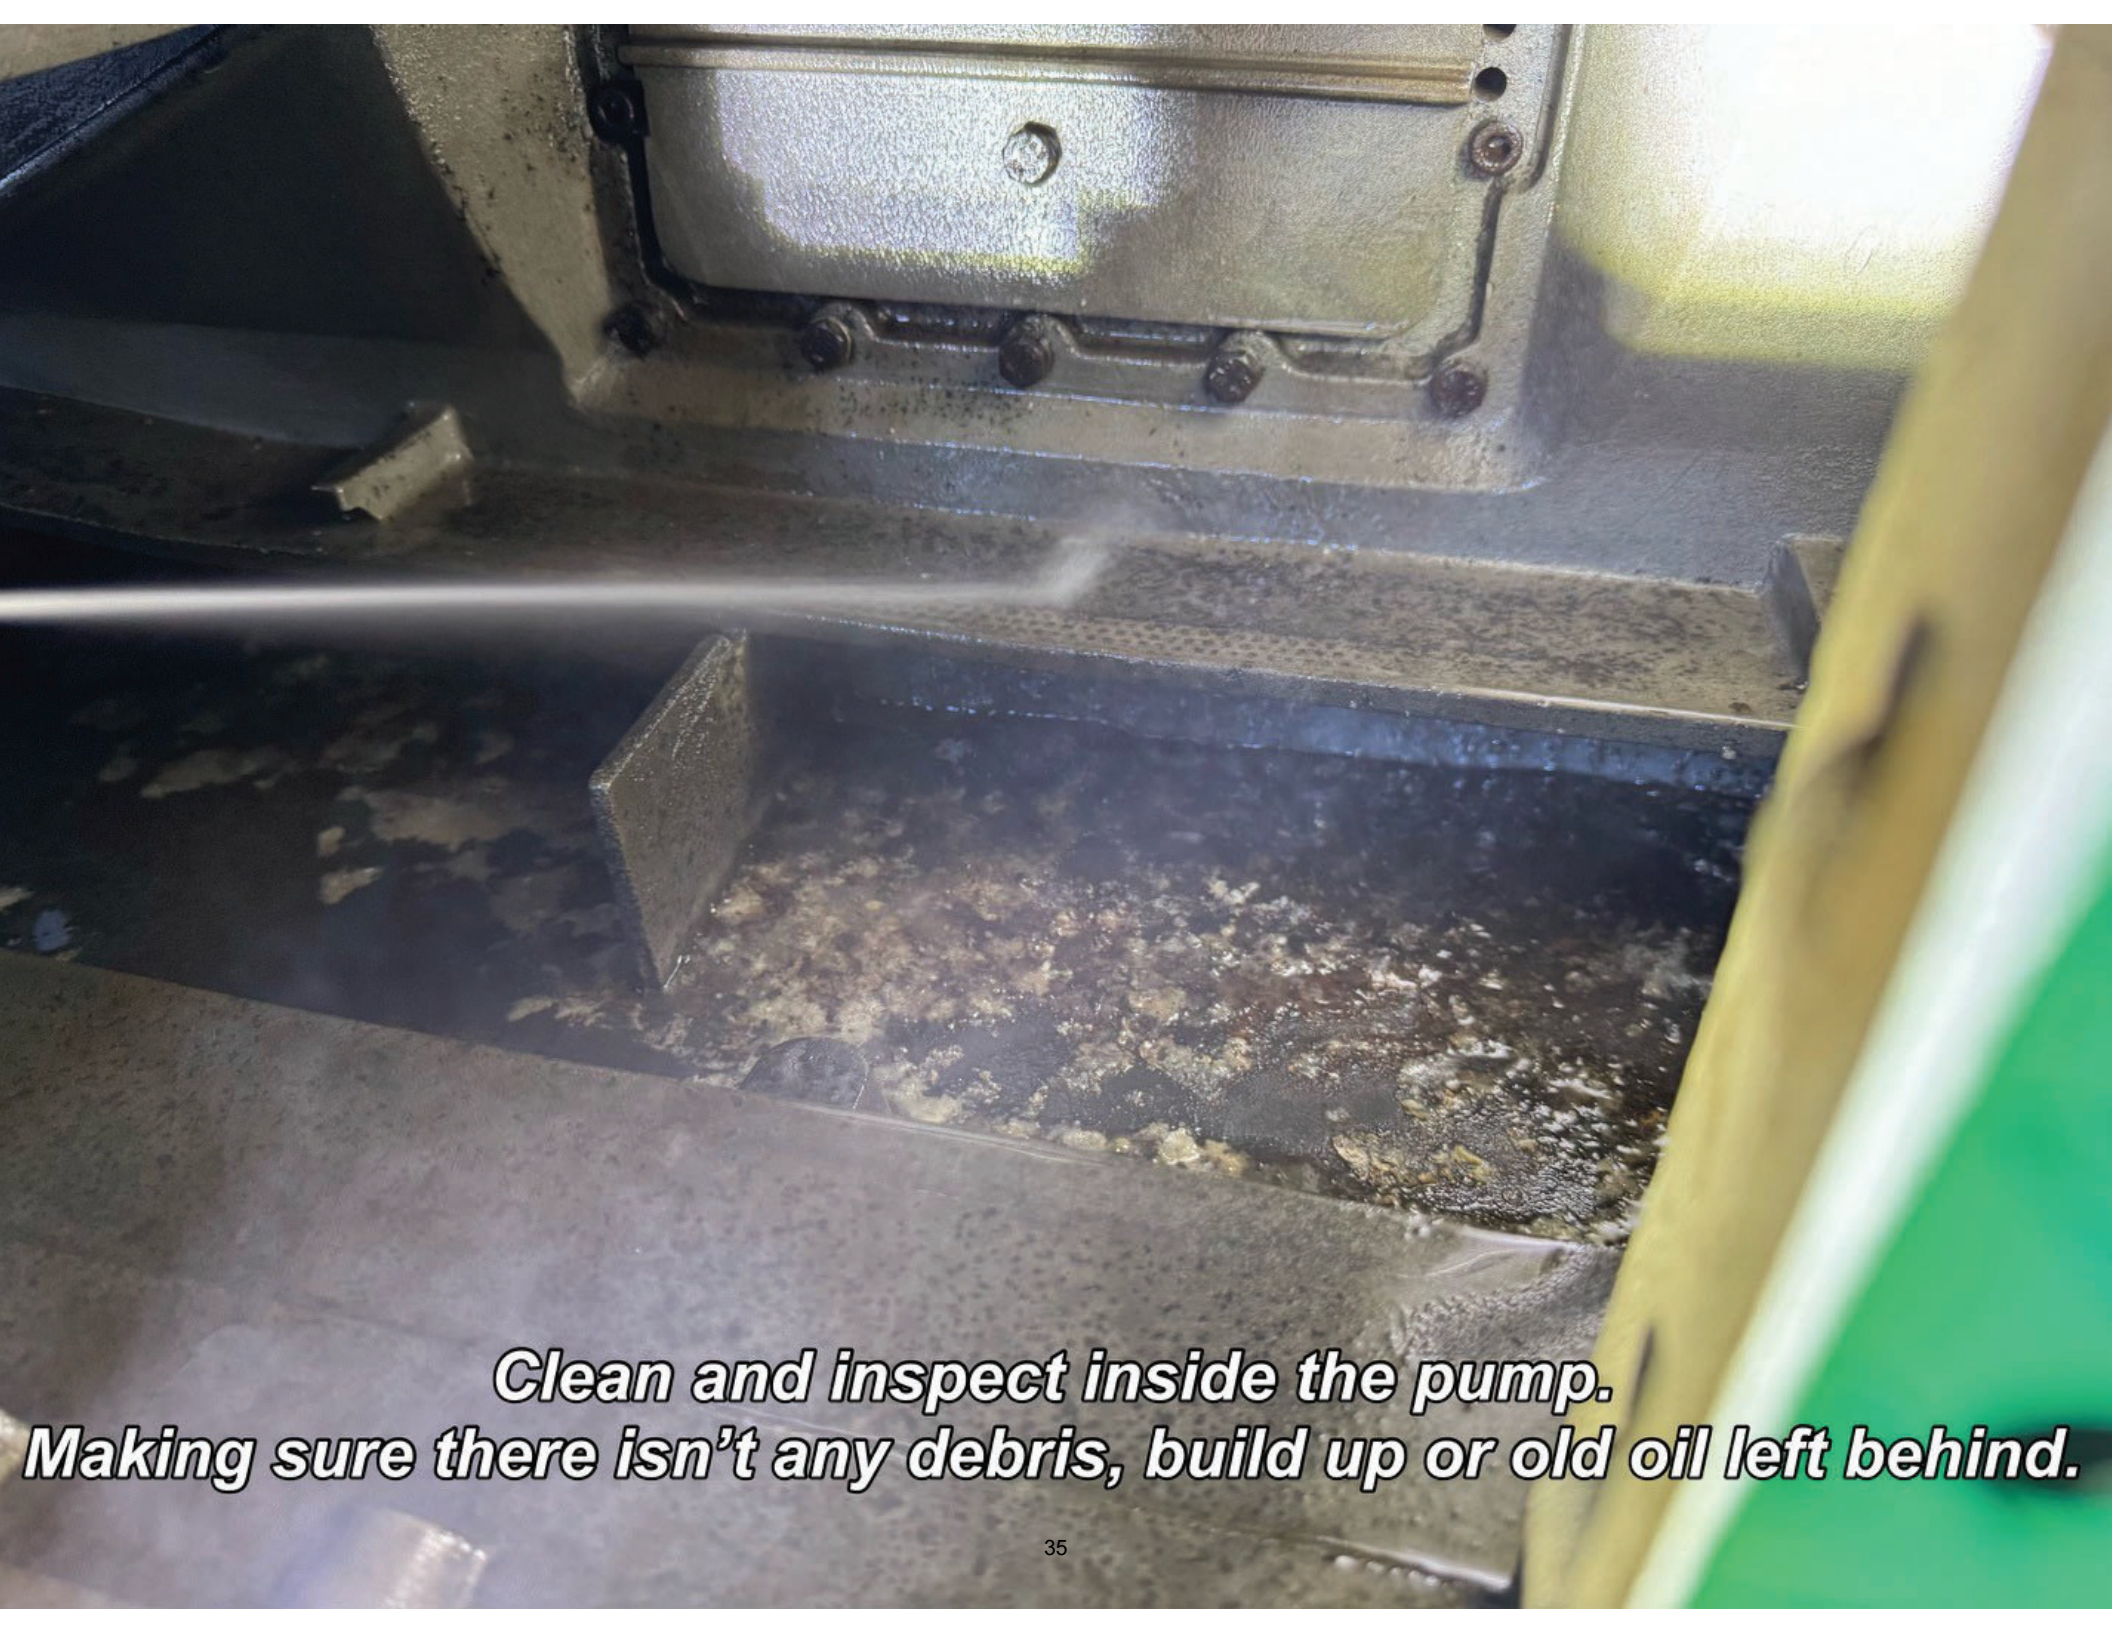
***Clean and inspect inside the pump.  
Making sure there isn't any debris, build up or old oil left behind.***

*Clean screens*
