Key Largo Wastewater Treatment District Board of Commissioners Meeting Agenda Item Summary

Subject:
Cleanout Cap Modifications

To: KLWTD Board of Commissioners
From: Steve Suggs, PE
Date: July 16, 2020
Re: KLWTD Cleanout Anti-Tampering Devices

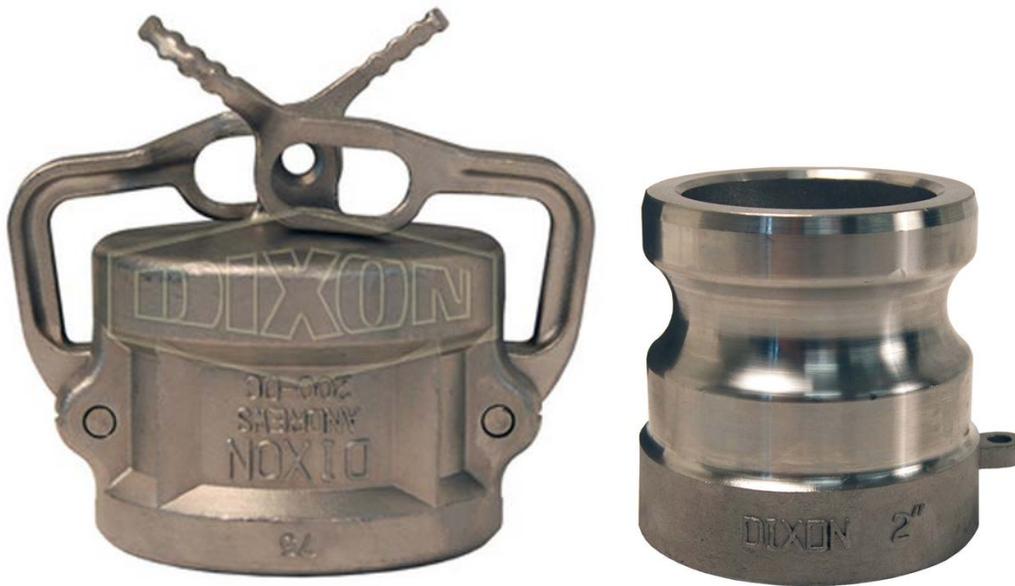
The second option considered is replacing the cleanout cap with a lockable camlock fitting. These are commonly used on fill ports for gas or chemicals. This will require some work to retrofit the fitting onto the cleanout. This type of modification will make accessing the cleanout very difficult for non KLWTD staff as it will have a lock and key. It is likely the pipe would be broken in the process of removing the camlock without the key. An image of a camlock cap can be seen below.

The cost of a stainless steel camlock male and female 6" fitting is approximately \$600.00. It is recommended that the camlocks only be put on known problem areas, not the entire collection system.
