Key Largo Wastewater Treatment District Board of Commissioners Meeting Agenda Item Summary

Subject:
Field Report - January 2025

Wastewater Field Operations

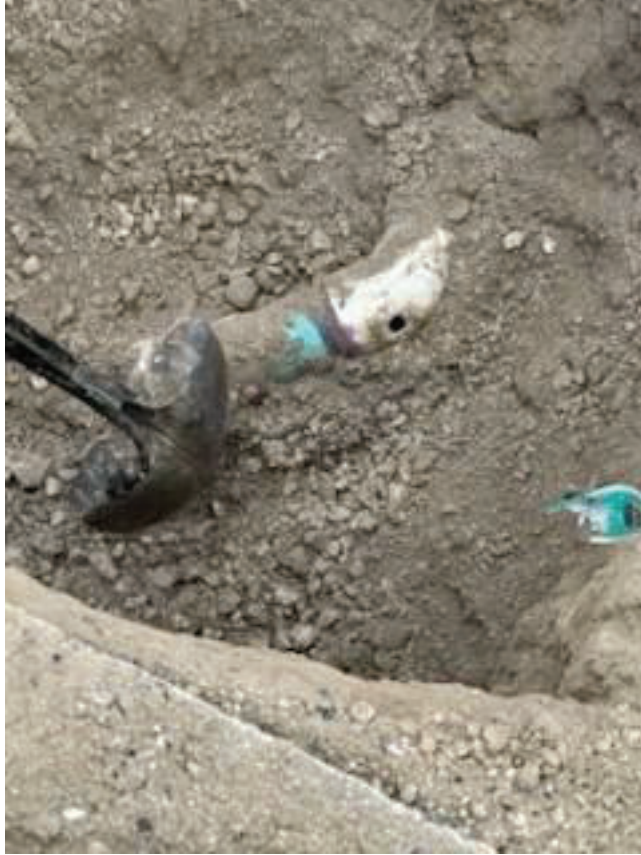
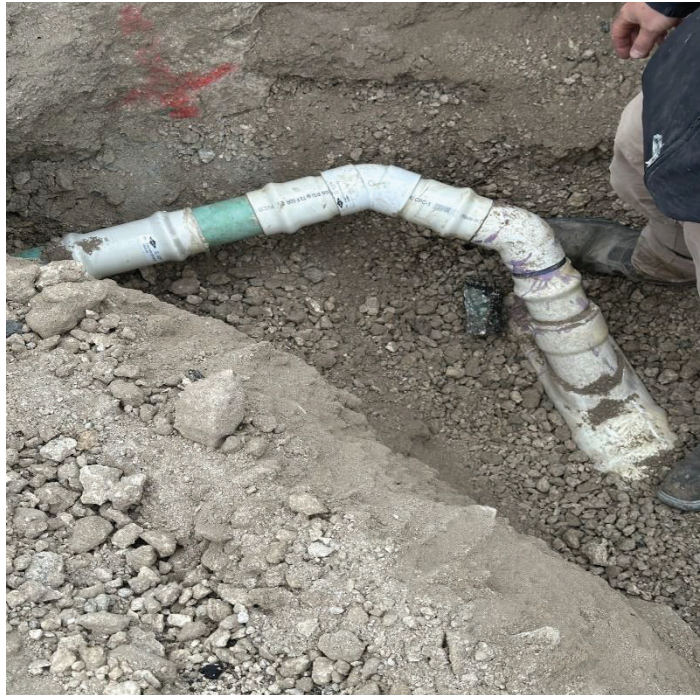
Tina Pl and Michelle Dr. Punctured 45* coming off vacuum main to street service line.
Created a struggle at Vac Station D with a constant loss of vacuum during day time hours.

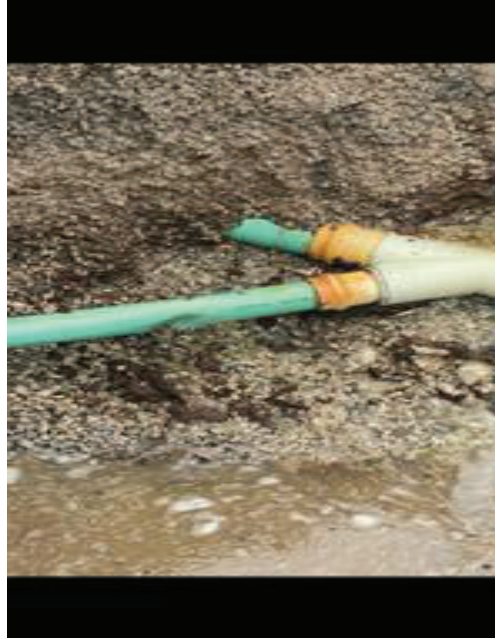
1013 Adams contractors doing storm drains on Shaw Dr and Adams struck our vacuum line with bucket of excavator cracking the pipe. Crews responded promptly to dig site and quickly repaired leak

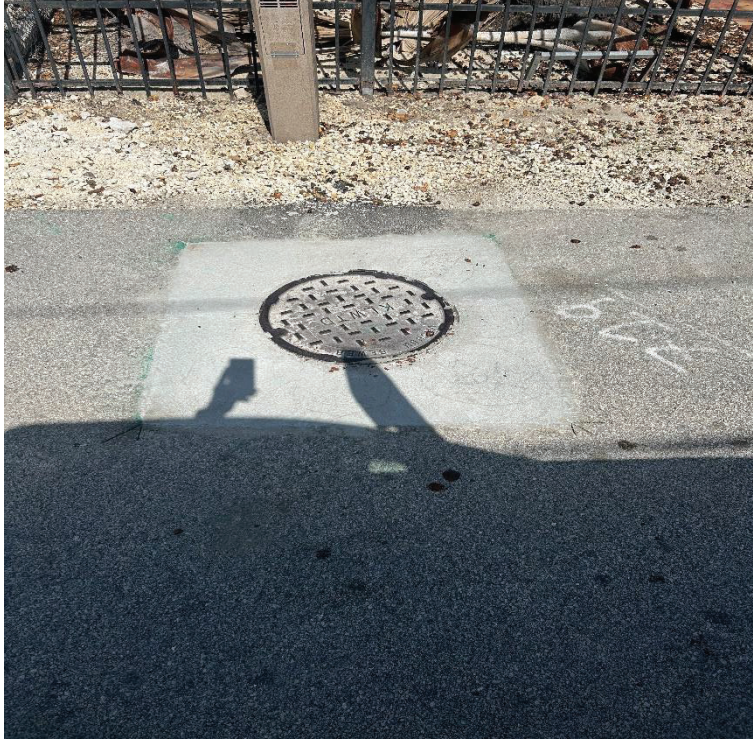
719 Grouper Lane manhole ring damaged and repaired with new ring and 6" concrete slab reinforced with rebar

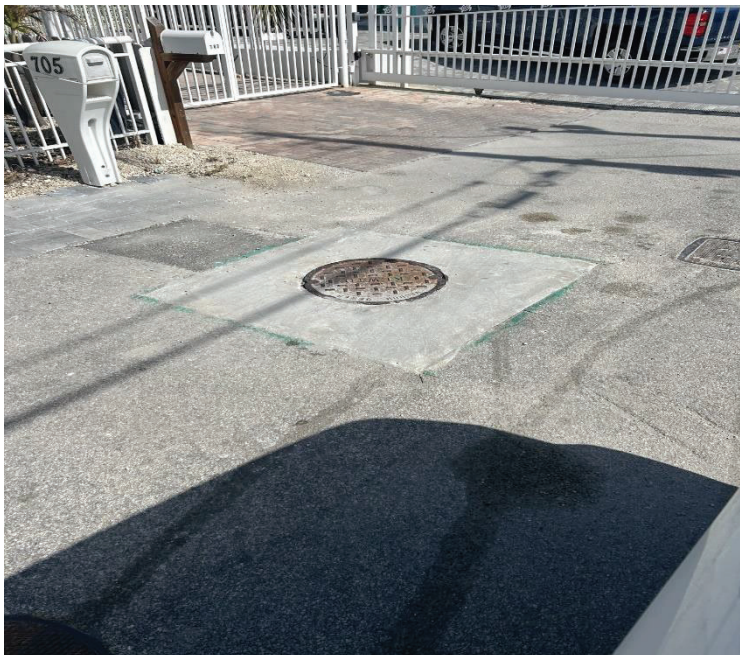
705 Grouper Lane manhole ring damaged and repaired with new ring and 6" concrete slab with rebar reinforcement

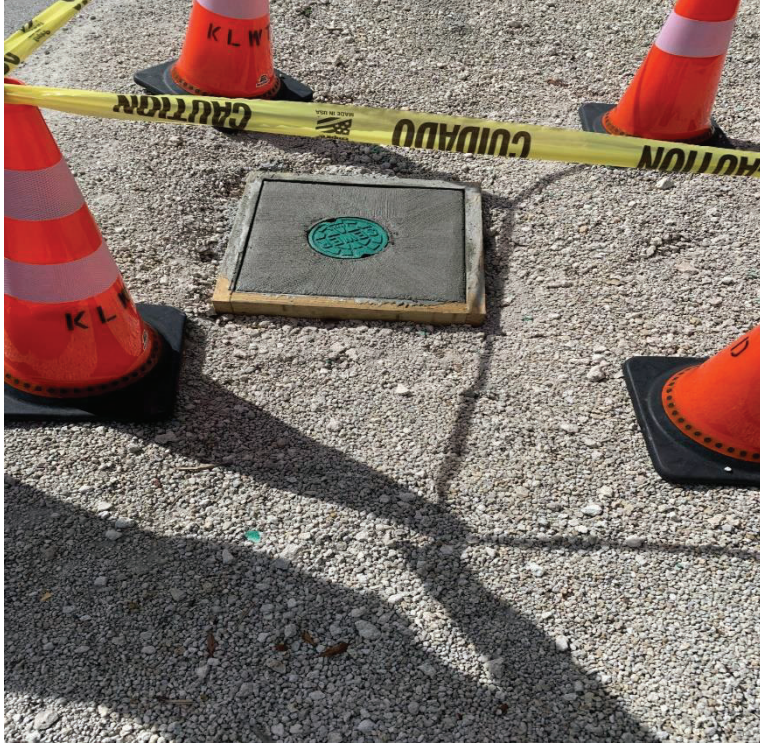
New 6" concrete valve box slab Oakwood and Sexton.
